Winchendon Senior Center  
Conditions Assessment  
January 2020

### **Winchendon Senior Center**

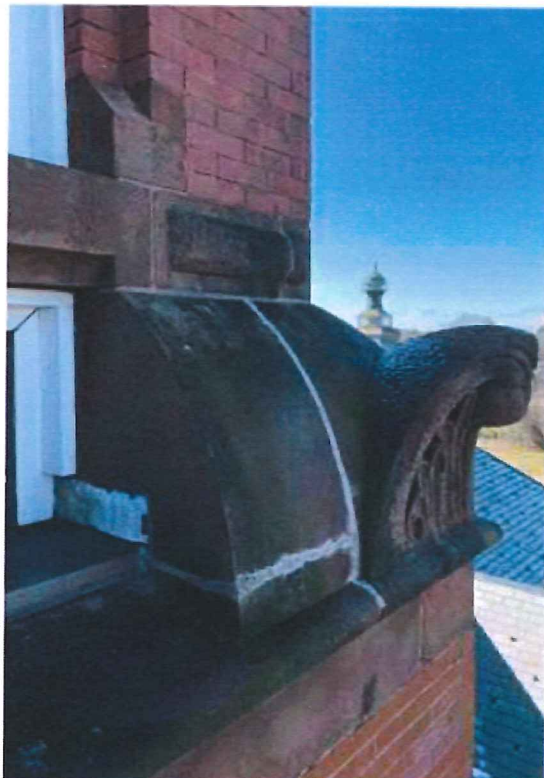
**Photo 2 - Massive  
Curved Stones  
Transition Tower  
Exterior Masonry from  
30" at Level 3 = 3 to 8"  
for the Remaining  
Height**

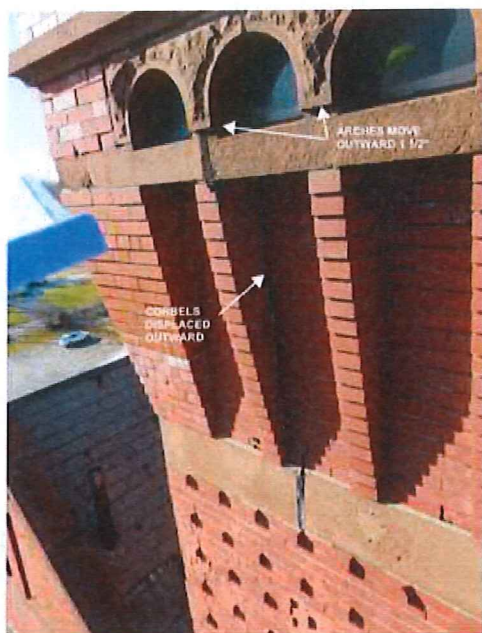
**Photo 3 - Single Wythe Corbels of Tower Displaced Outward**

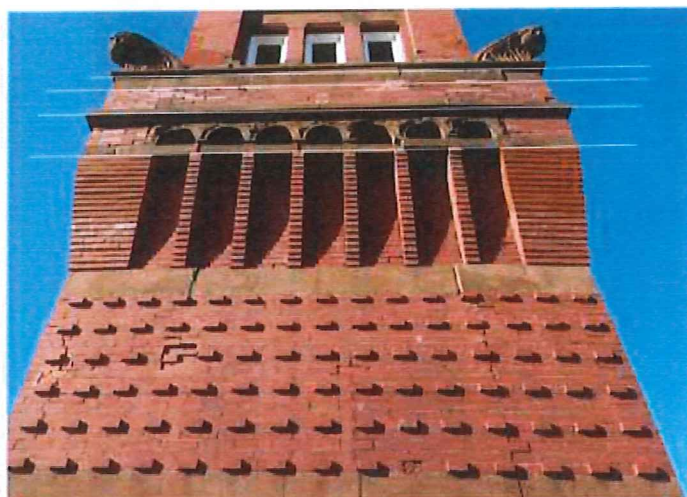
**Photo 4 - Distortion of Tower Masonry Above 7-Arches**

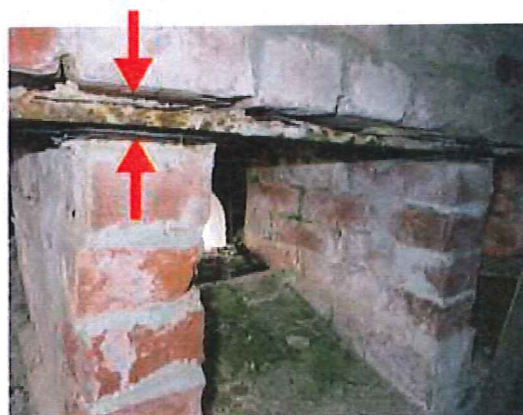
**Photo 8 - Rust Jacked Steel Plate Linels at 7 - Arch opening Brick Backup**

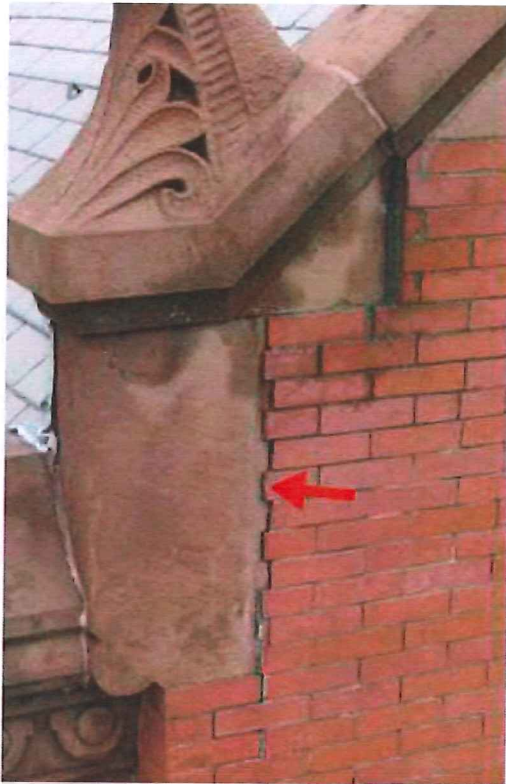
**Photo 9 - Brick Proud of Brownstone  
Due to Outer Wythe Delamination**

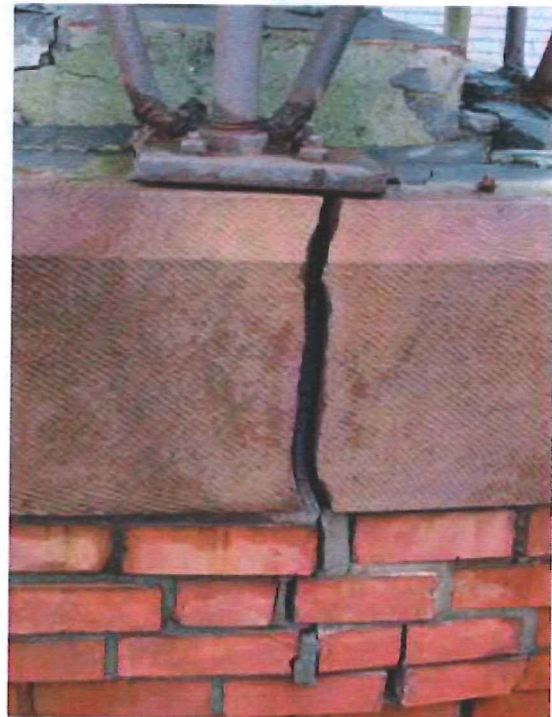
**Photo 10 - Ventilator Base  
Corroding and Splitting Stone**

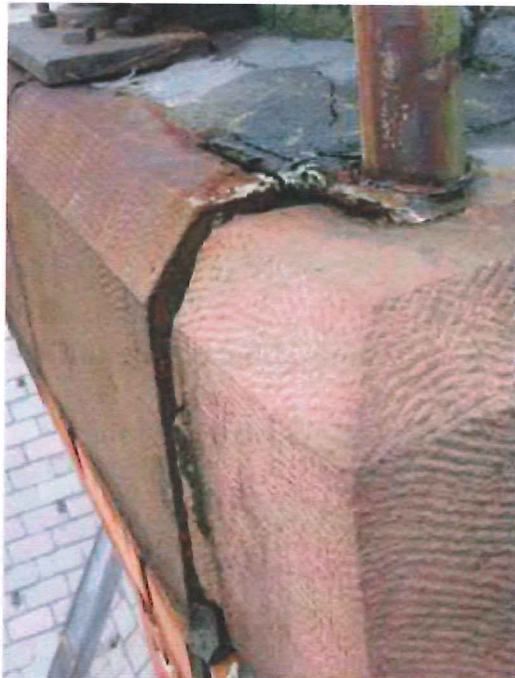
**Photo 11 - Ventilator Base  
Corroding and Splitting Stone**

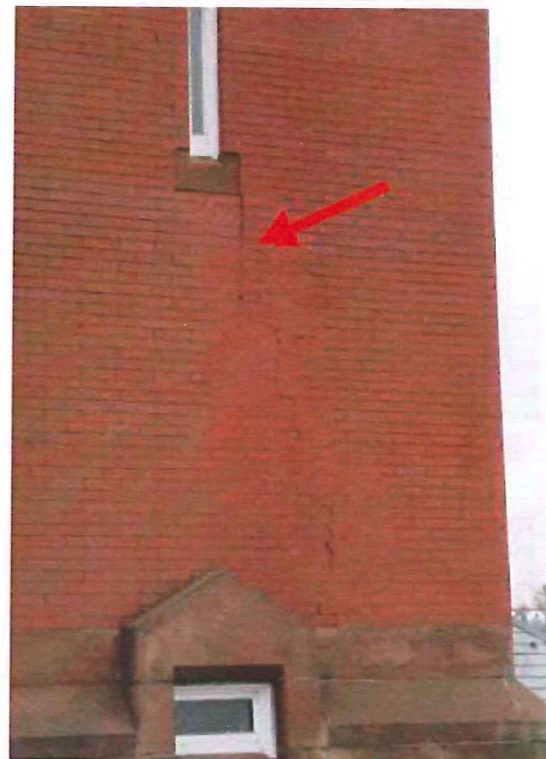
**Photo 11 - Rebuild Bricks Across  
Cracks in Lower East Tower**

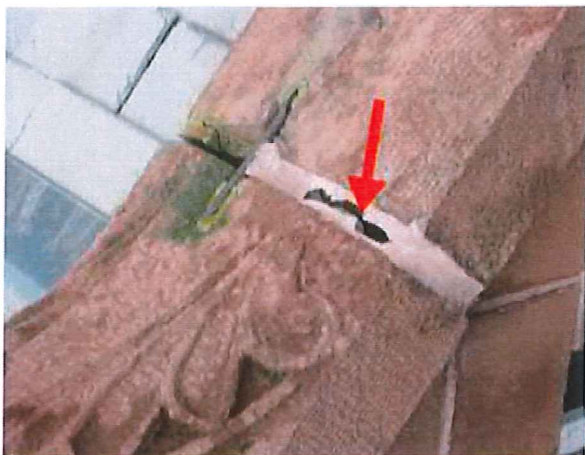
**Photo 12 - Open Joint in  
Gable End Brownstone  
Coping Cap**

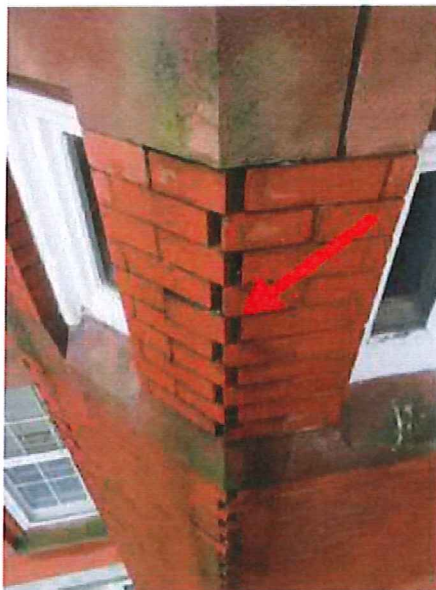
**Photo 13 - Open Joint in  
Faceted Turret Corners**

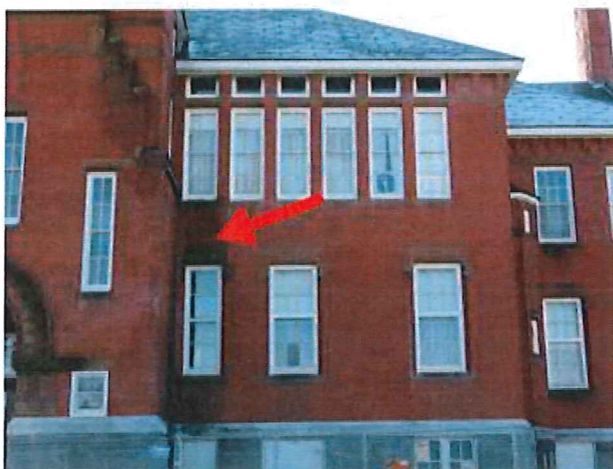
**Photo 14 - Organic  
Growth West Side of  
North Elevation**

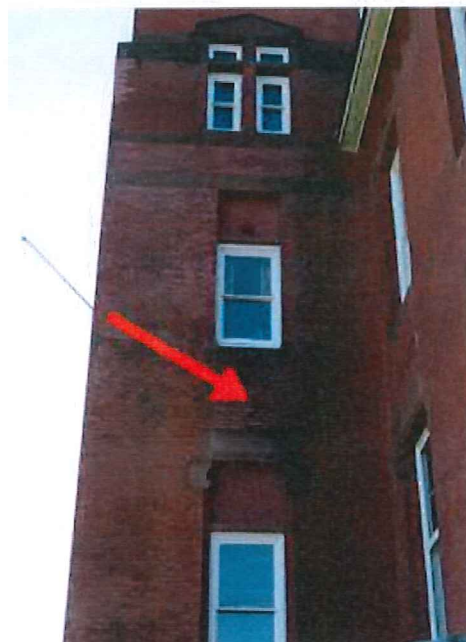
**Photo 15 - Organic  
Growth West Side of  
Lower Tower**

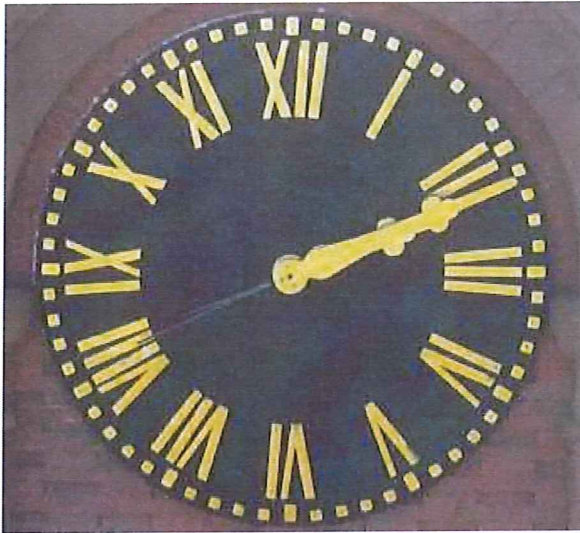
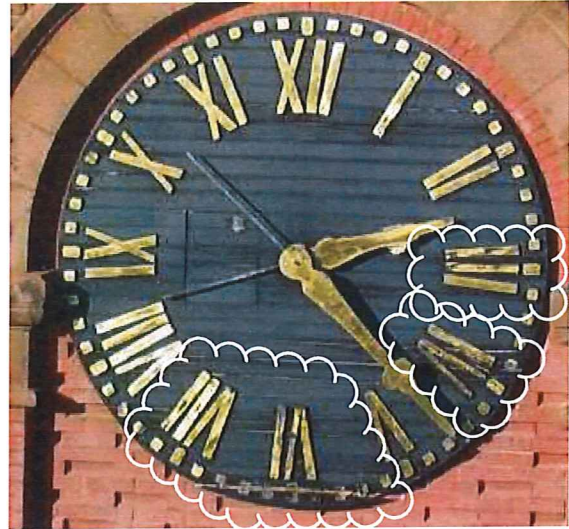
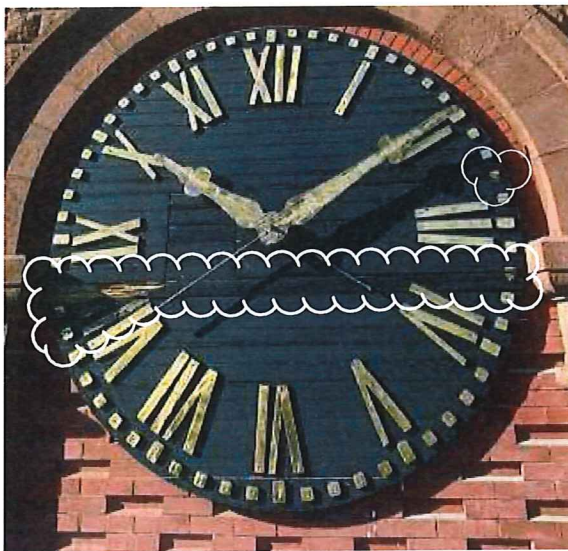
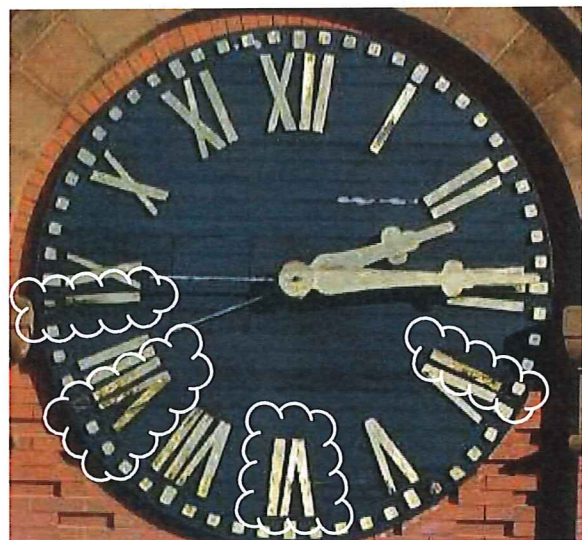
## TOWER CLOCK FACES

- East Face - Wood rot was observed extending horizontally across the middle of the clock face
- South Face - Wood rot was observed on the bottom of the clock face between 3 and 7
- West Face - Wood rot was observed on the bottom of half of the clock face at several locations between 4 and 9

ROT DAMAGED  
AREAS OF WOODEN  
CLOCK FACE ARE  
SHOWN CLOUDED

- Replace the sections of the wood clock face that are deteriorated

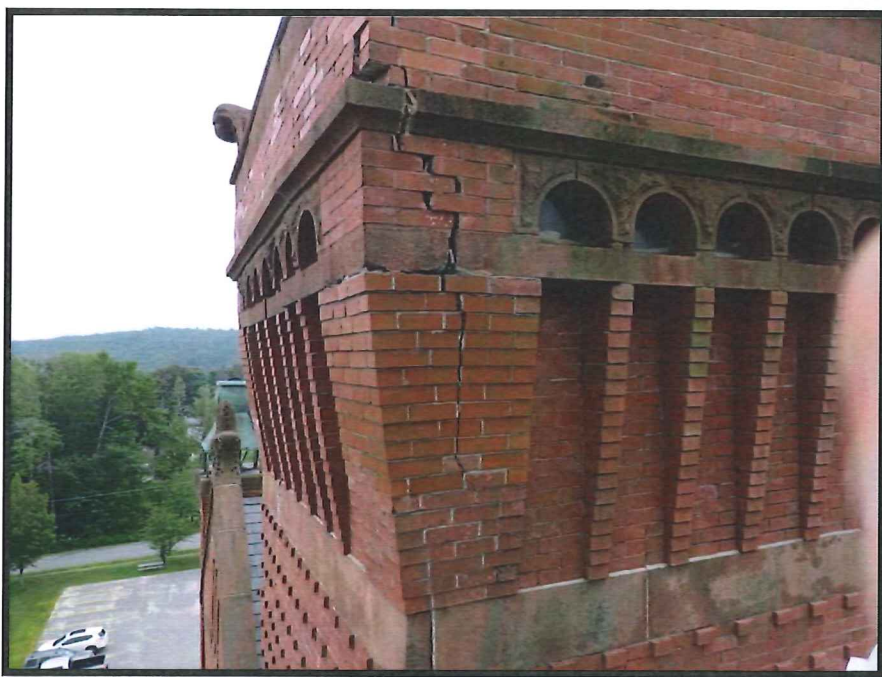
Appendix B – Photo -1

- The deterioration of the clock tower façade at elevation 3+2 includes cracks in the southeast corner of the clock tower where the east face of the brick masonry is separated from the clock tower (See photo 1 Appendix B). Corresponding cracks were also observed in the east face at the northeast corner of the tower where the brick is sheared through and a crack approximately 1-inch wide has resulted (See photo 2 Appendix B).

- Selectively demolish the outer brick wythe and brown stone and rebuild the facade using a mixture of old and new brick and brown stone of matching size and shape
- Remove the corroded steel flat plate lintels supporting the brick masonry above the seven arched windows and infilling the space between brick piers that currently are supporting the lintels with solid masonry. Once the infill masonry is complete, the brownstone can be anchored to the newly installed solid masonry.
- Install supplemental stainless-steel helical anchors to tie the newly constructed face brick back to the inner wythes of the masonry walls
- Install supplemental stainless-steel helical anchors to tie the existing face brick to the inner wythes for the masonry walls for the remainder of the clock tower face

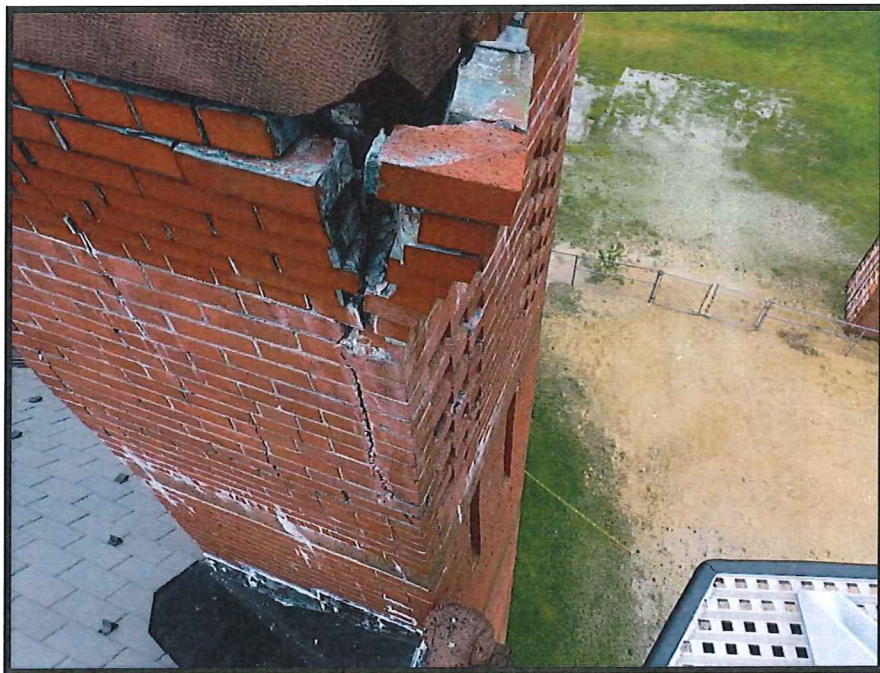
Appendix B – Photo 4

- The ventilation chimneys on the east and north elevations are badly deteriorated. The deterioration observed includes split capstones, and cracks in the corbeled chimney brick (See photo 4 Appendix B). In addition, the iron posts supporting the copper cap will need protection to prevent corrosion because of dissimilar metals (See photo 5 Appendix B).
- The ventilation chimney on the south elevation is in good condition, except for the iron posts supporting the copper cap. The post will need protection to prevent corrosion because of dissimilar metals (See photo 6 Appendix B).
- The deterioration observed for the active boiler chimney located on the west elevation includes cracked brick and deteriorated mortar joints (See photo 7 Appendix B)

- Remove the copper chimney caps and steel support post to allow for masonry façade repairs

- Provide corrosion protection for the steel support posts. The corrosion protection to include sandblast surface preparation and a high-performance coating system.
- In addition, provide dissimilar metal isolators between the copper cap and steel support posts
- Selectively demolish the outer wythes chimney face brick and brown stone cap and rebuild the facade using a mixture of old and new brick and brownstone
- Install supplemental stainless-steel helical anchors to tie the newly constructed face brick to the inner wythes of brick masonry

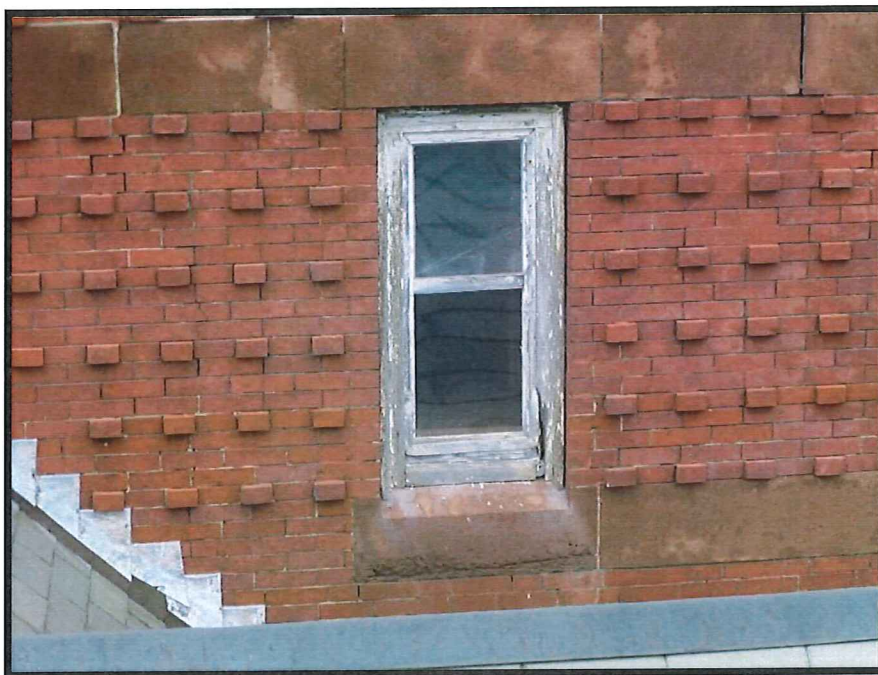
Appendix B – Photo 8

- The window on the south side of the clock tower is in poor condition. Wood rot is visible on the window frame (See photo 8 Appendix B)
- The window units located on the north side of the clock tower beneath the roof interface are also in poor condition. Wood rot is visible on the window frame (See photo 9 Appendix B).

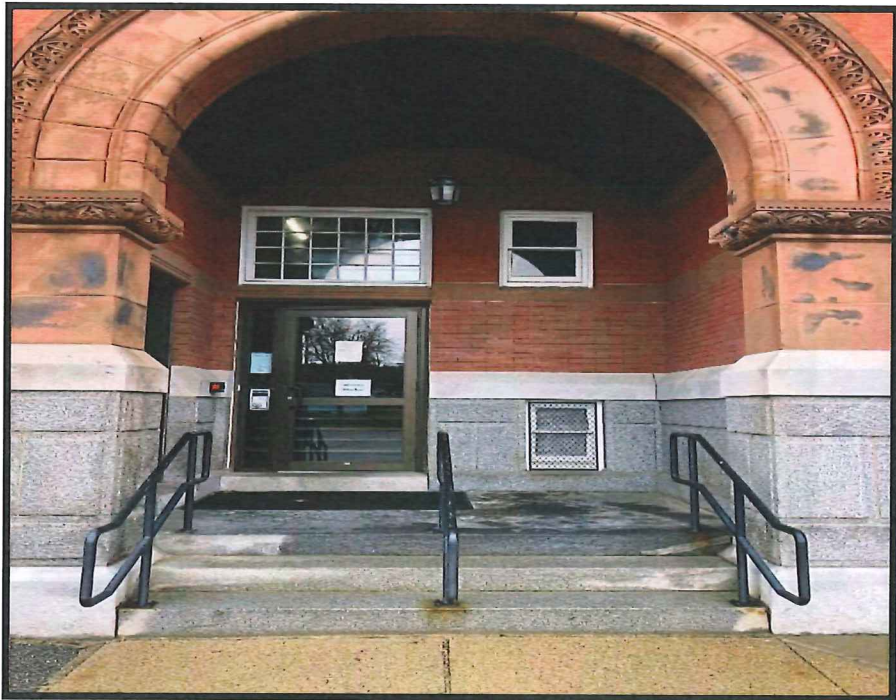
Appendix B – Photo 10

- The entrance door located on the south elevation is located approximately 4 risers (2'-4") above grade. The aluminum door and frame are in good condition. The door appears to be relatively new (See photo 10 Appendix B). There is also a wood door located adjacent to the aluminum entrance door. The door is inactive, and the hardware has been removed. The wood door is in fair condition.

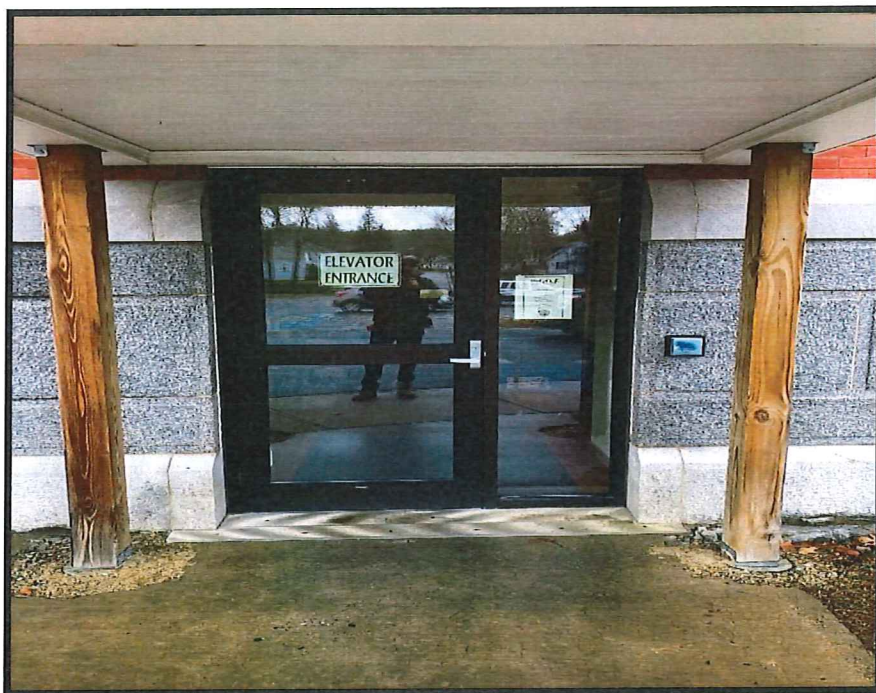
Appendix B – Photo 11

- The second entrance door located on the south elevation is an at grade entrance and provides access to the building elevator and access to all floors of the facility. The aluminum door and frame are in good condition. The door appears to be relatively new (See photo 11 Appendix B).

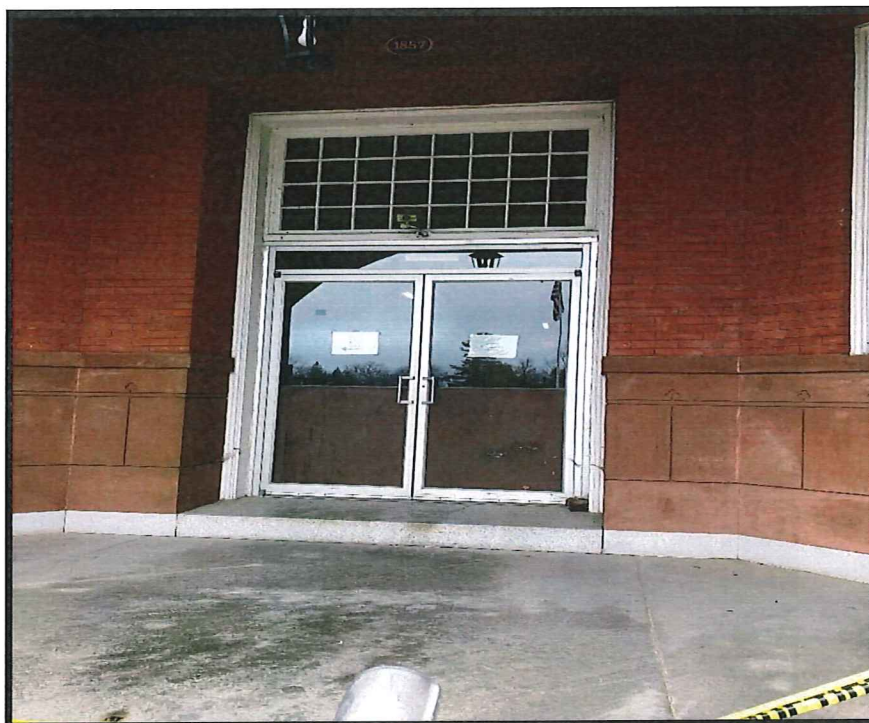
Appendix B – Photo 12

- The entrance door located on the east elevation is located approximately 12 risers (7'-0") above grade. The aluminum door and frame are in fair condition, but appears to be older than the building entrance doors located on the south and north elevations (See photo 12 Appendix B).

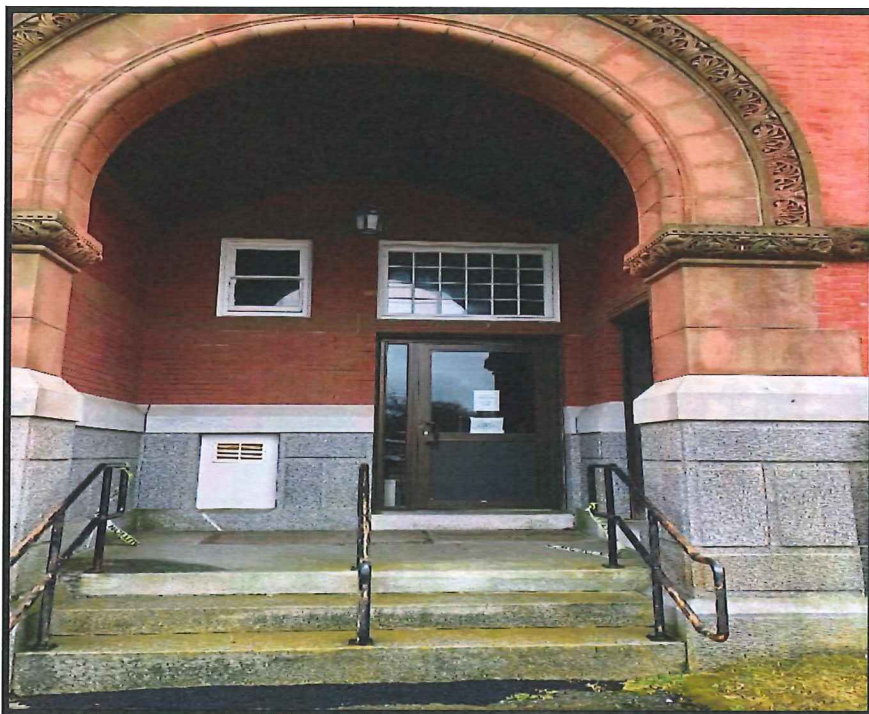
Appendix B – Photo 13

- The entrance door located on the north elevation is located approximately 4 risers (2'-4") above grade. The aluminum door and frame are in good condition. The door appears to be relatively new (See photo 13 Appendix B). There is also a wood door located adjacent to the aluminum entrance door. The door is inactive, and the hardware has been removed. The wood door is in fair condition.

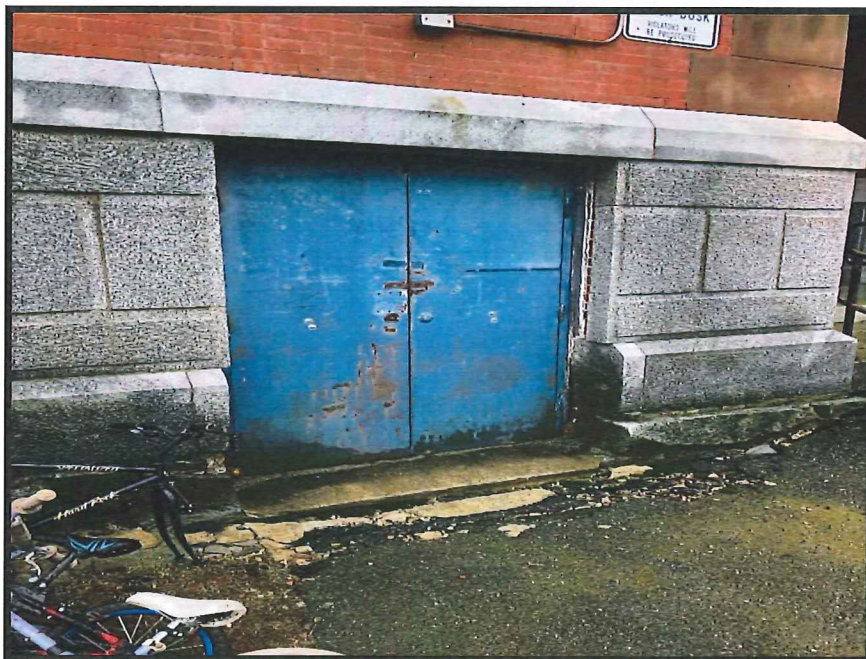
Appendix B – Photo 14

- The north elevation also includes a hollow metal double door that provides access to the basement. The double door is in poor condition. Corrosion is visible on the door and frame (See photo 14 Appendix B).

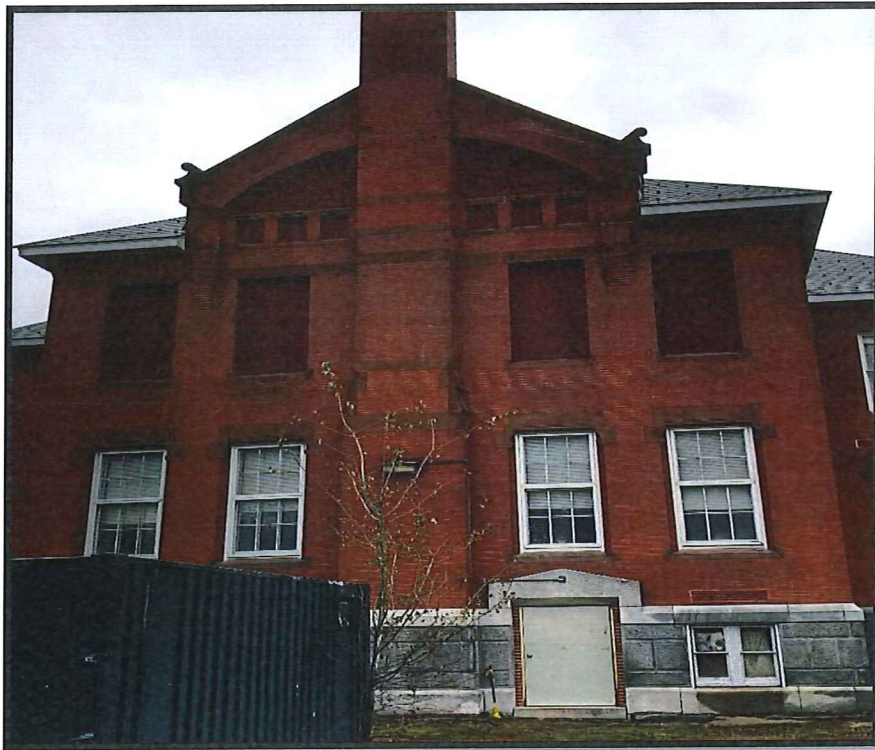
Appendix B – Photo 15

- The west elevation includes an access door to the basement. The single door is in fair condition (See photo 15 Appendix B).

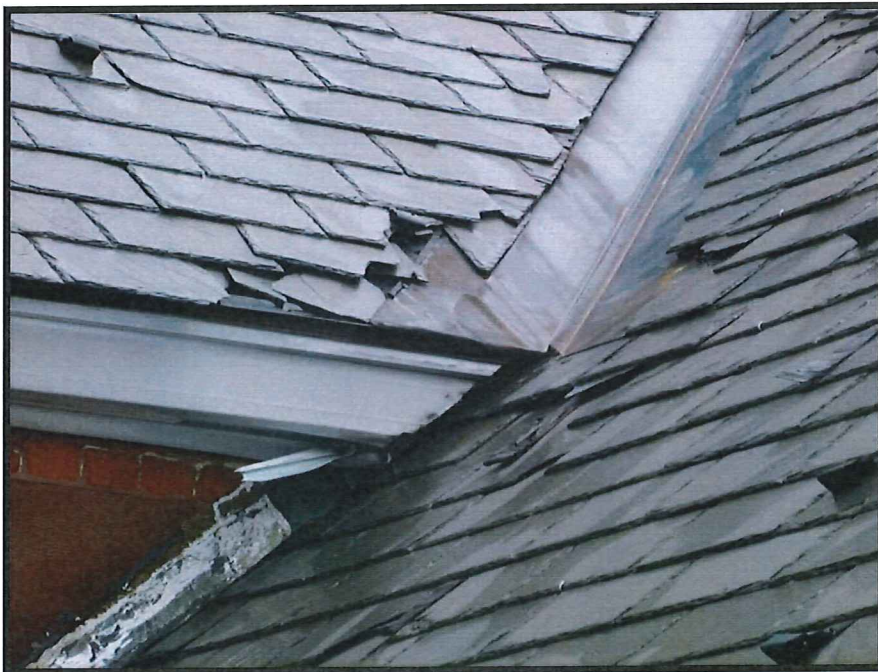
Appendix B – Photo 16

- We observed some broken and fractured slate (See photo 16 Appendix B)
- It was also observed that gable wall parapet flashing is damaged (See photo 17 Appendix B), most likely caused by sliding snow and ice. In general, all observed

- Reinstall existing salvaged slate and supplement with new slate to facilitate roof repairs, incorporate new copper flashing in accordance with industry standards and practices.

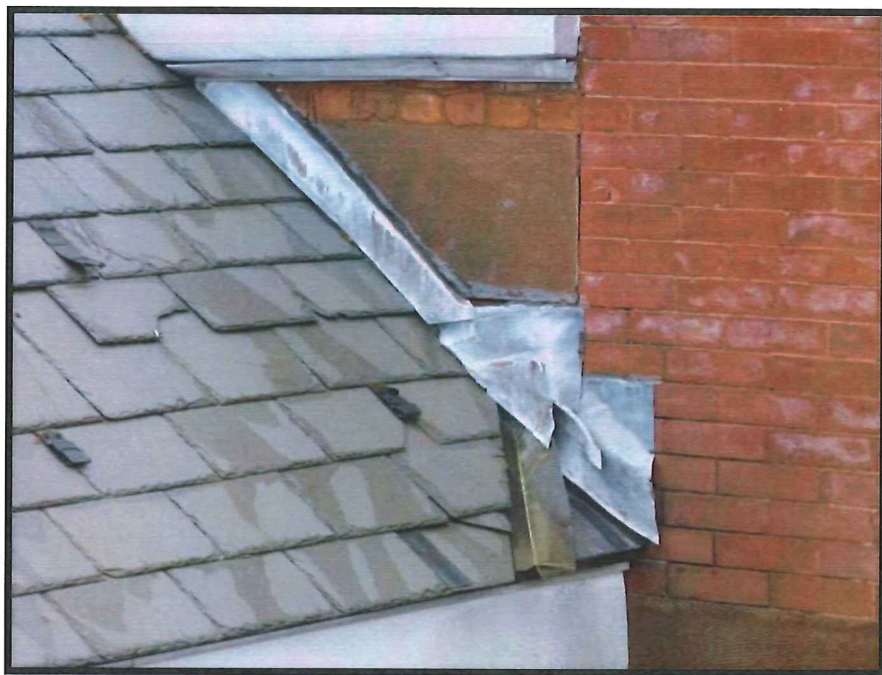
Appendix B – Photo 18

flashings appear to be in fair condition and will require some repairs in conjunction with the roofing repairs (See photo 18 Appendix B).

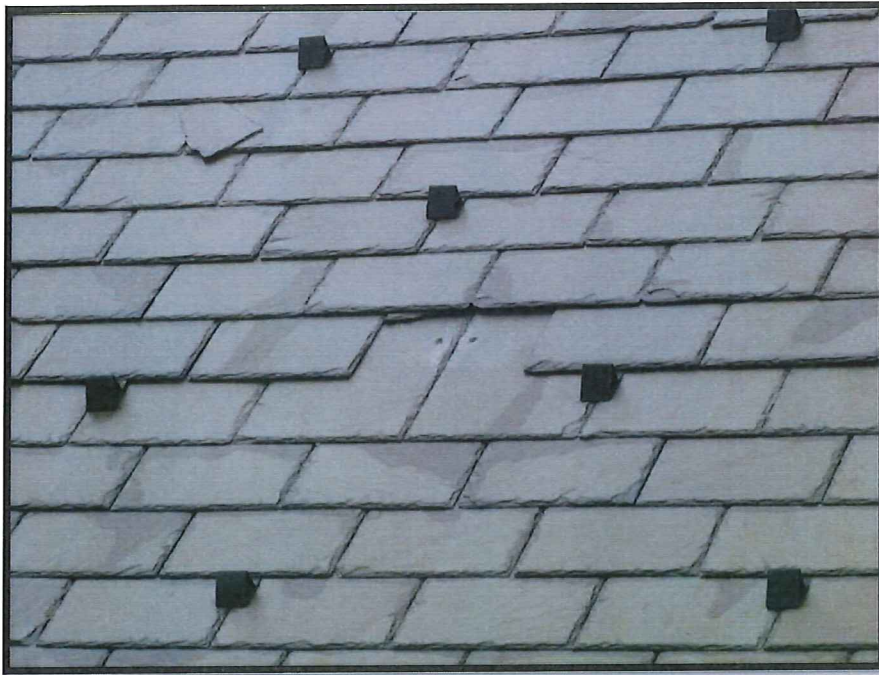
Appendix B – Photo 19

- The existing snow pads currently installed on the roof appear to be sub-par and should be replaced with better quality product as part of the roof repairs (See photo 19 Appendix B)

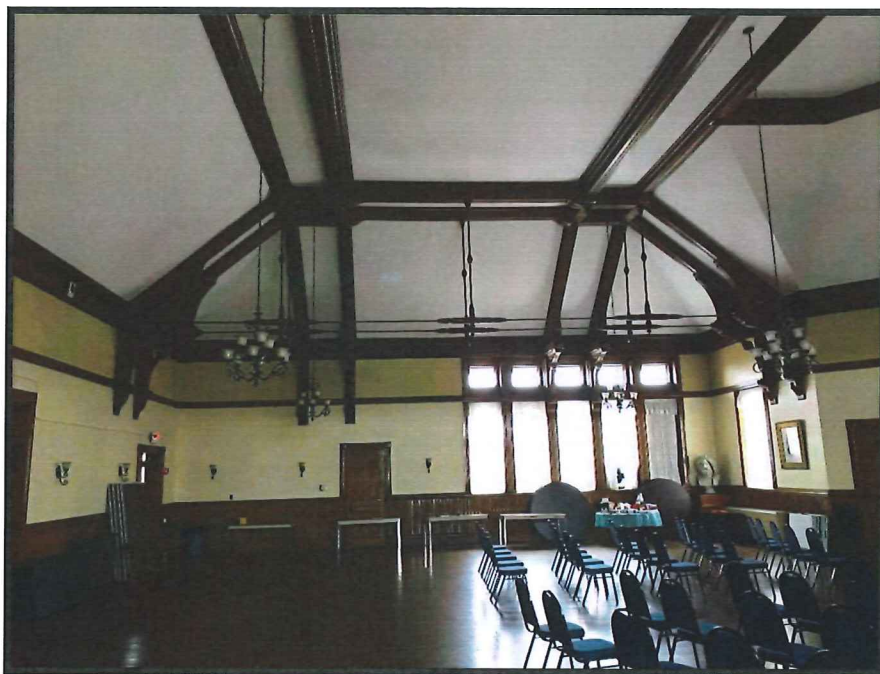
Appendix B – Photo 21

- The auditorium has exposed ornate wood trusses (See photo 21 Appendix B) and wood doors (See photo 22 Appendix B) and are in very good condition
- The wood flooring is also in very good condition, we did not observe any noticeable sagging or deflections (See photo 23 Appendix B)

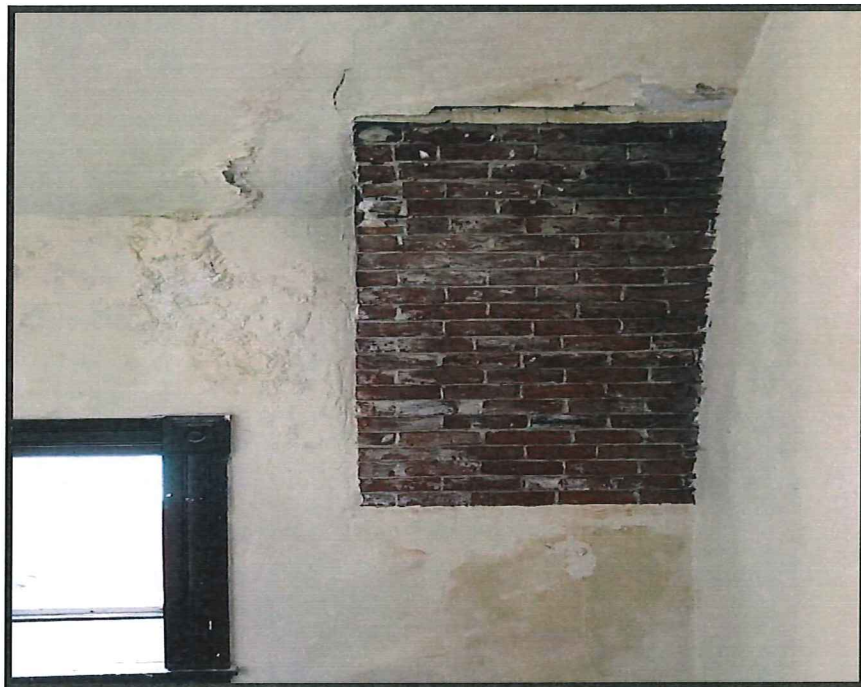
Appendix B – Photo 24

- We observed water infiltration on the west wall of the north stairwell leading up to the third floor (See photo 24 Appendix B)
- The second floor has men's and women's rest rooms with one toilet and lavatory fixture for each. There is also a convenience shower facility.

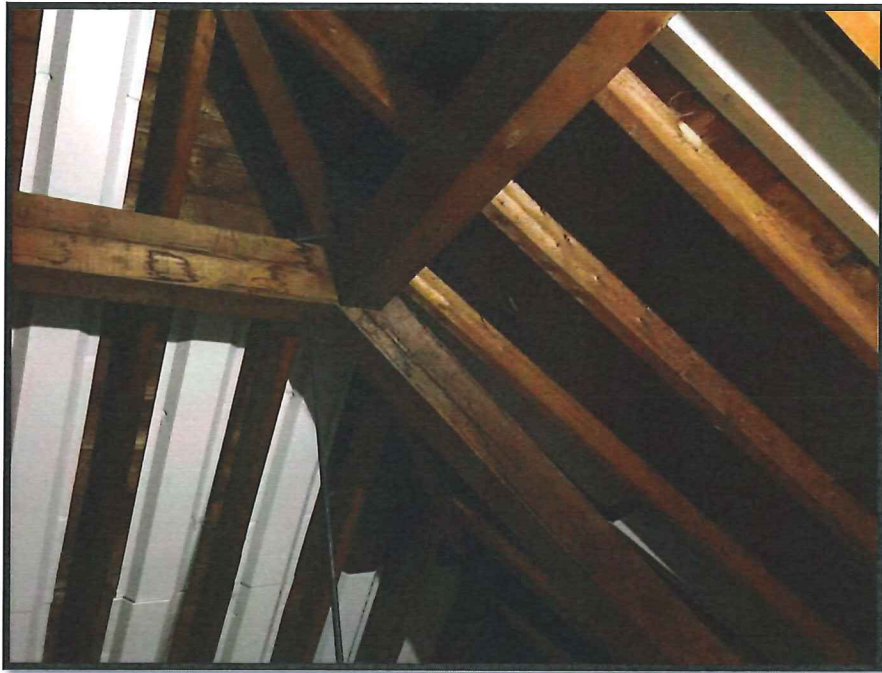
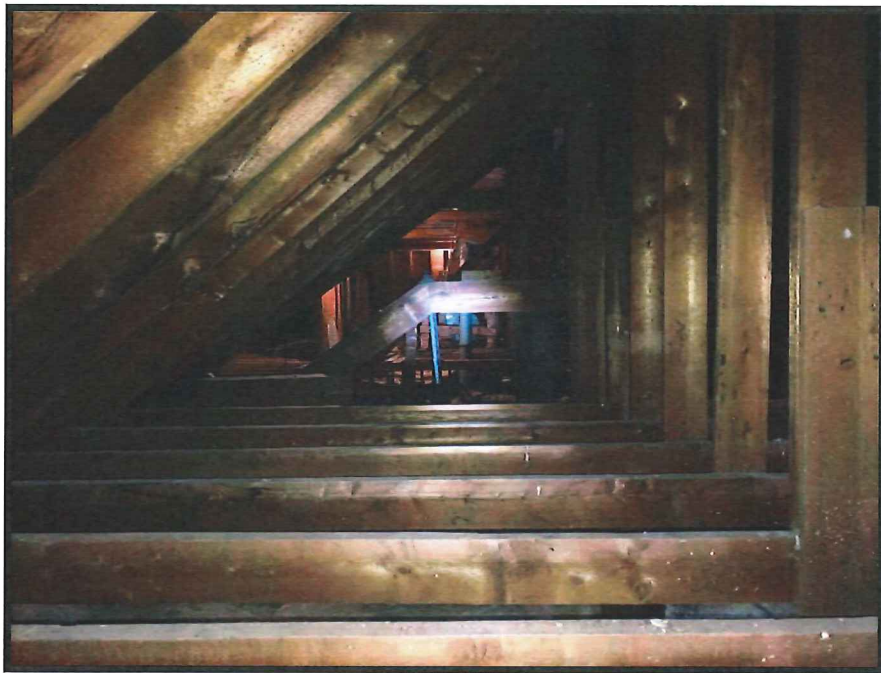
- The roof framing that we observed was in good condition. We did not observe any evidence of distress or indications of water infiltration damage (See photos 25 and 26 Appendix B).
- We did observe and hear pigeons within the attic space

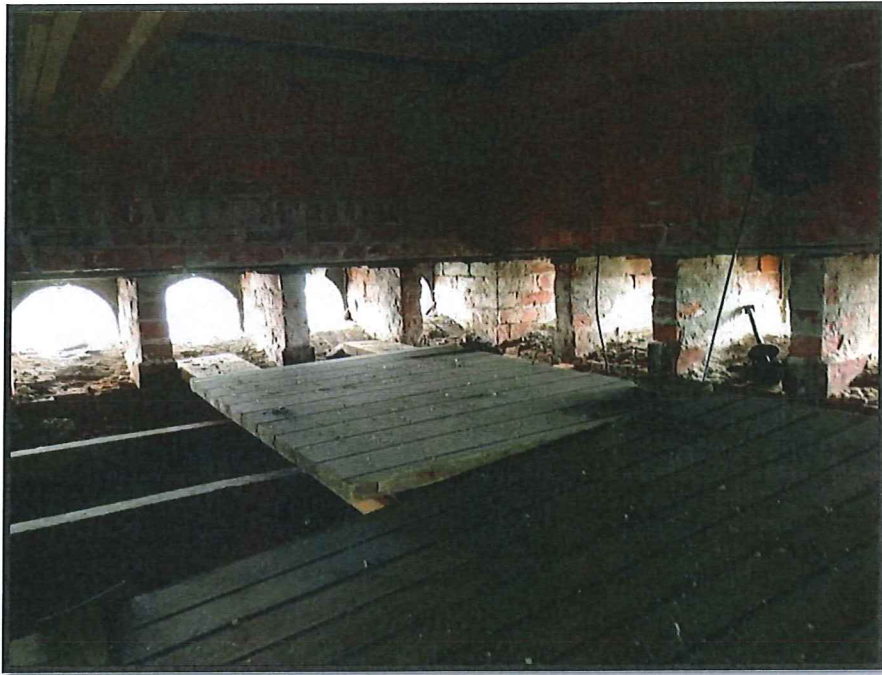
Appendix B – Photo 27

- The intermediate floor levels within the clock tower are constructed from wood framing and appear to be in fair condition (See photo 27 Appendix B)
- One of the rungs on the ladder up to the top level of the clock tower is broken and does not provide for safe access (See photo 28 Appendix B)
