Winchendon Landfill Site Observation – December 10, 2021

To: Brian Croteau, DPW Director
FROM: Aaron Sabbs, PE, Tighe & Bond
COPY: Tracy Murphy, Director of Planning and Development & Acting Planning Agent
Alex Fagnand, PE, Tighe & Bond
DATE: January 26, 2021

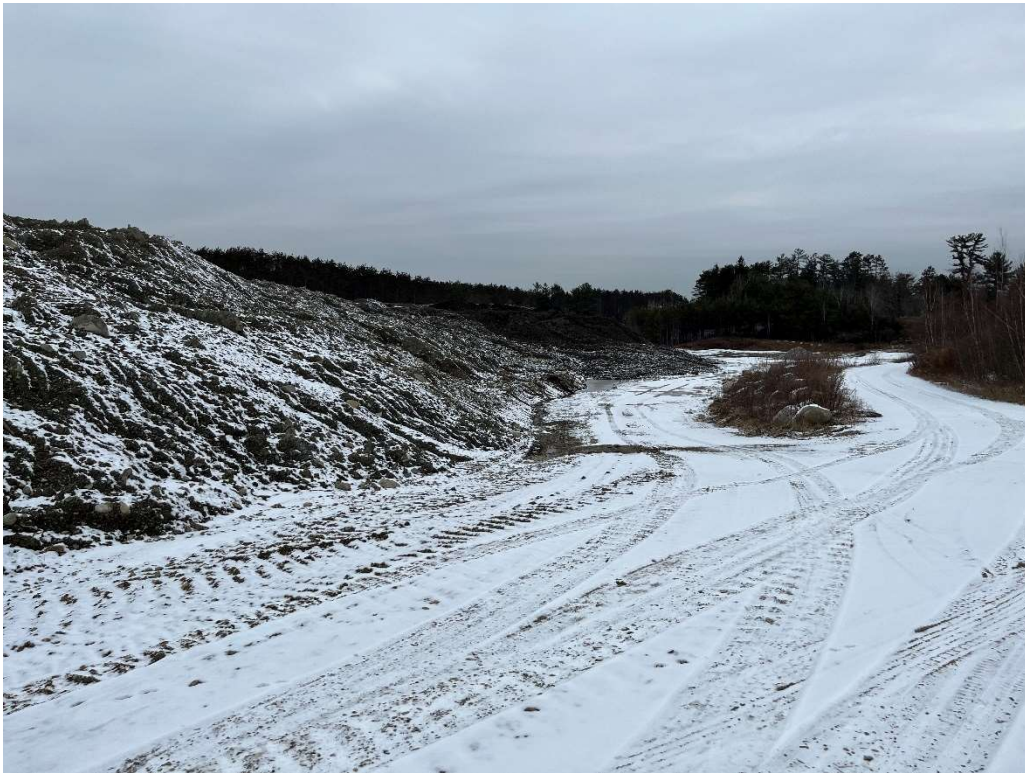
Photo 1 – Eastern slope and access road.

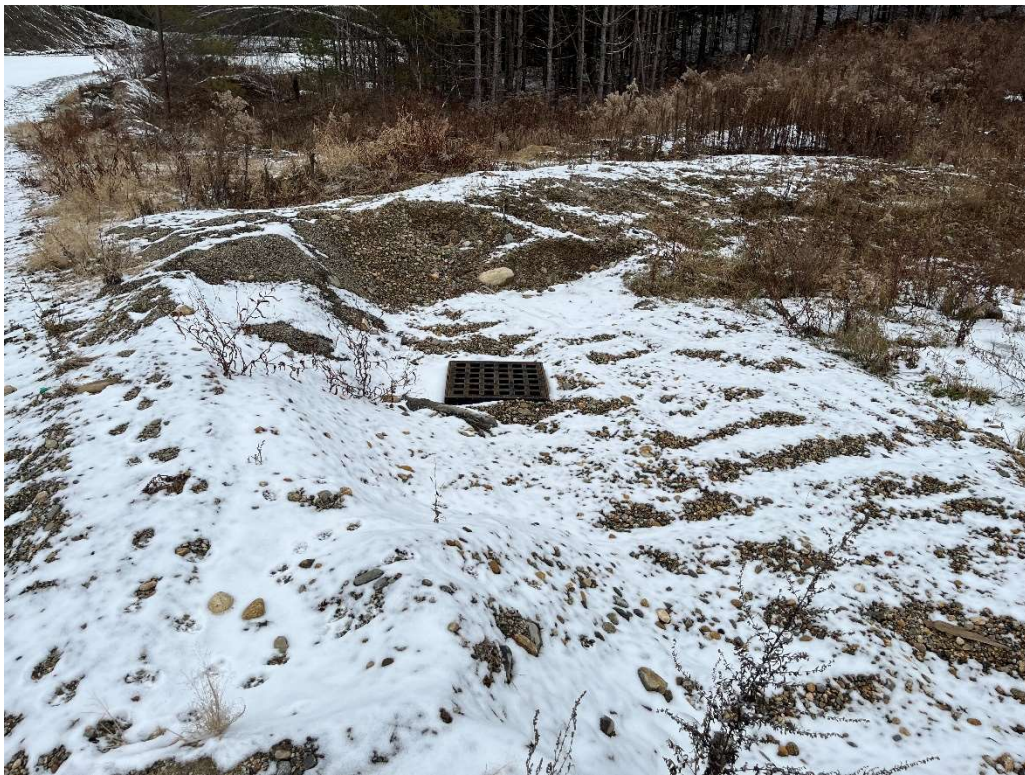
Photo 2 – Temporary stormwater overflow catch basin.

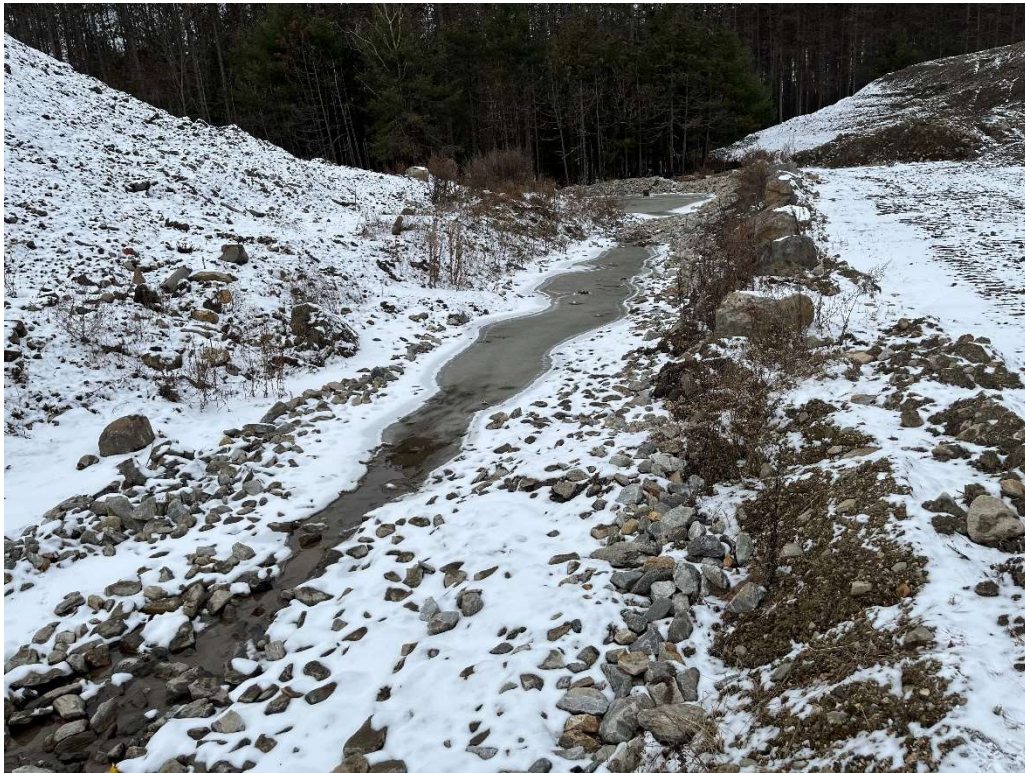
The swale had previously experienced significant sediment buildup and damage from heavy rainfall. The Operator has rebuilt portions of the swale and check dams, including installing additional rip rap to remedy the damage. The swale will require continued maintenance and cleaning, as sediment is still visible within the swale and settling area.

Photo 3 – Swale and check dams between temporary stormwater basin and temporary rip rap settling area.

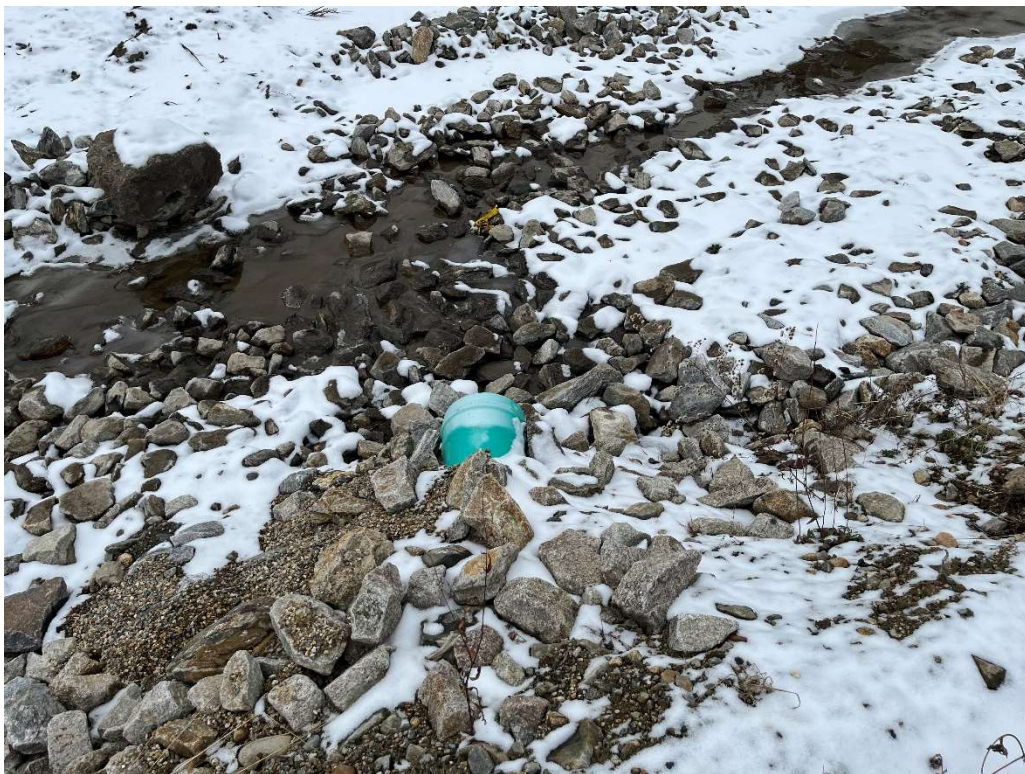
Photo 4 – Stormwater culvert under access road.

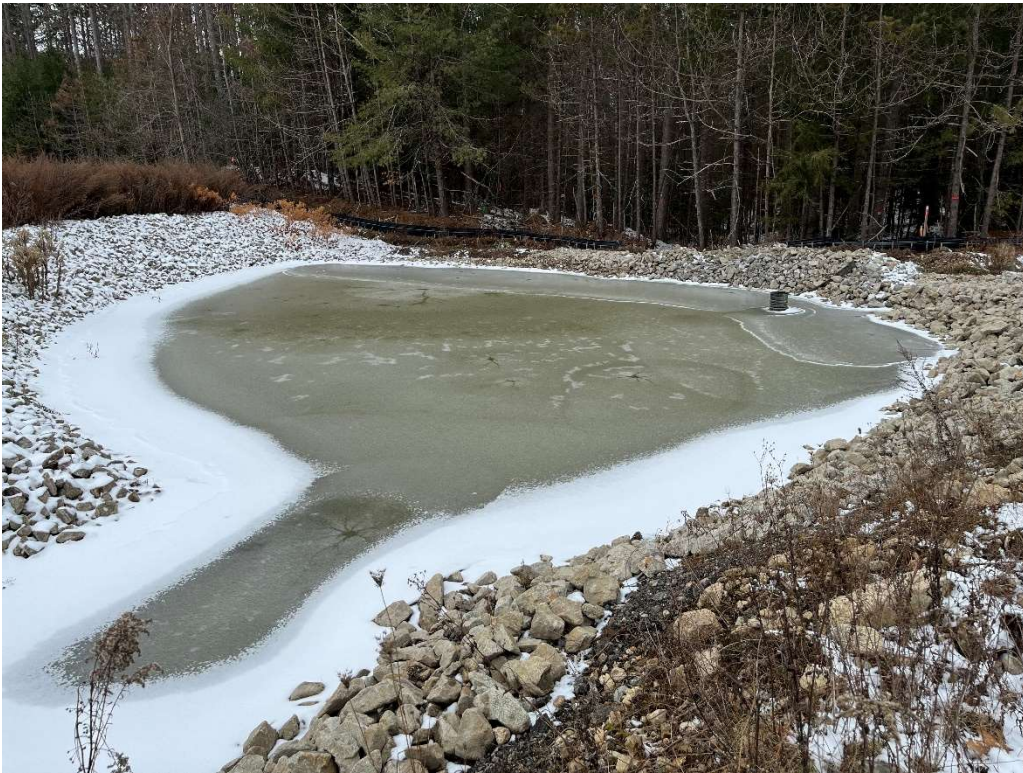
Photo 5 - Temporary rip rap settling area.

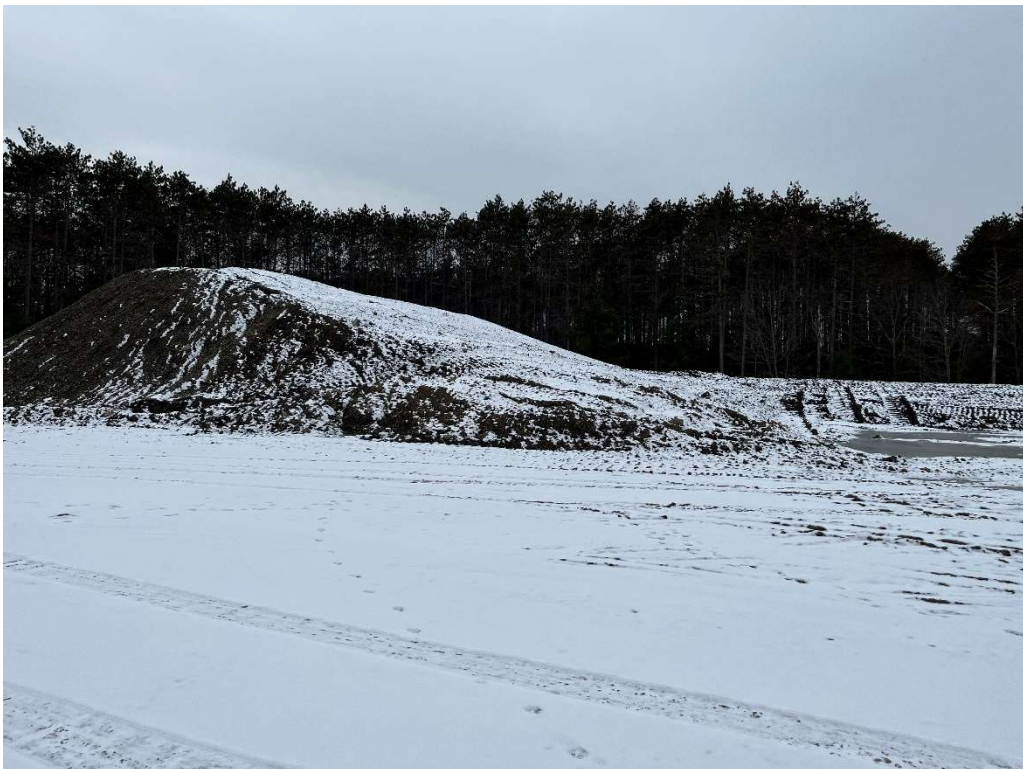
Photo 6 - Material placed and graded in the northern area of the site.

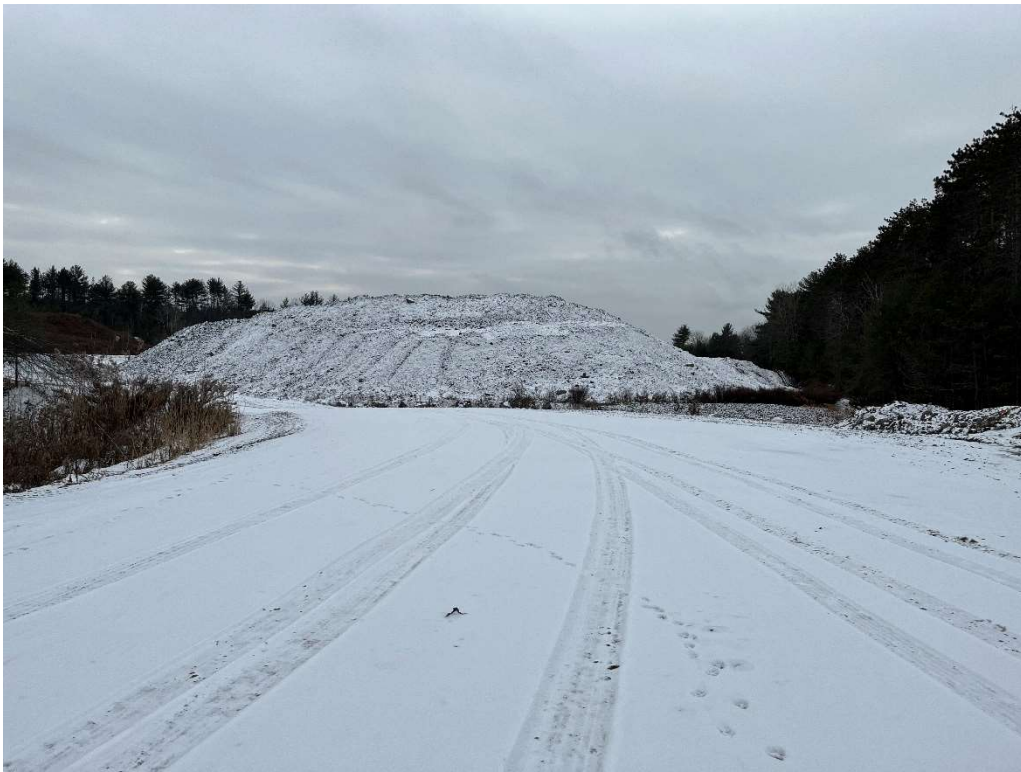
Photo 7 – Material placed and graded in the central area of the site.

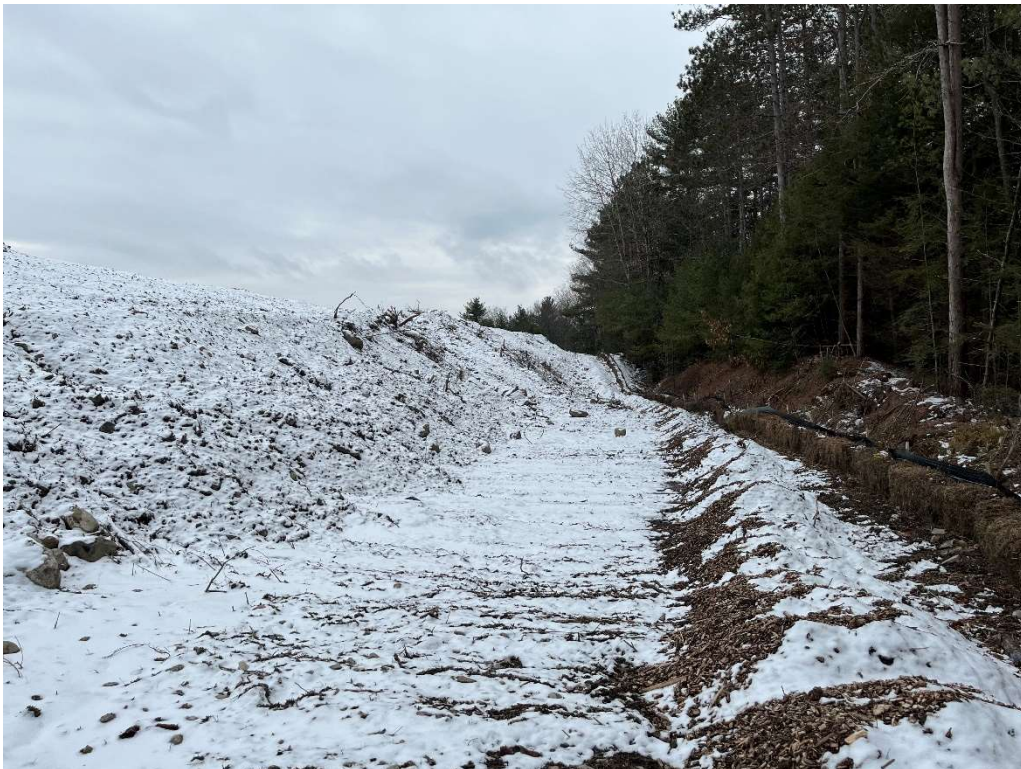
Erosion control was present along the northern, southern, and western edges of the site. There were no noted deficiencies in the erosion control.

Photo 8 – Representative view of erosion control on the western limits of the Site.

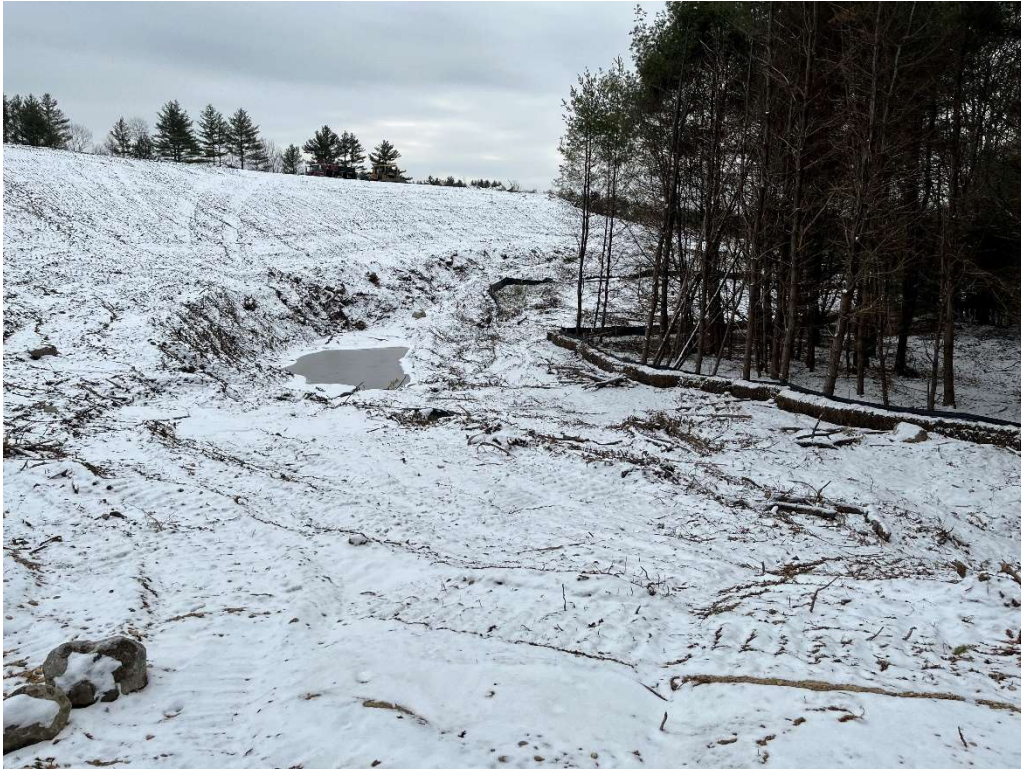
Photo 9 – Southwestern slope and erosion control.

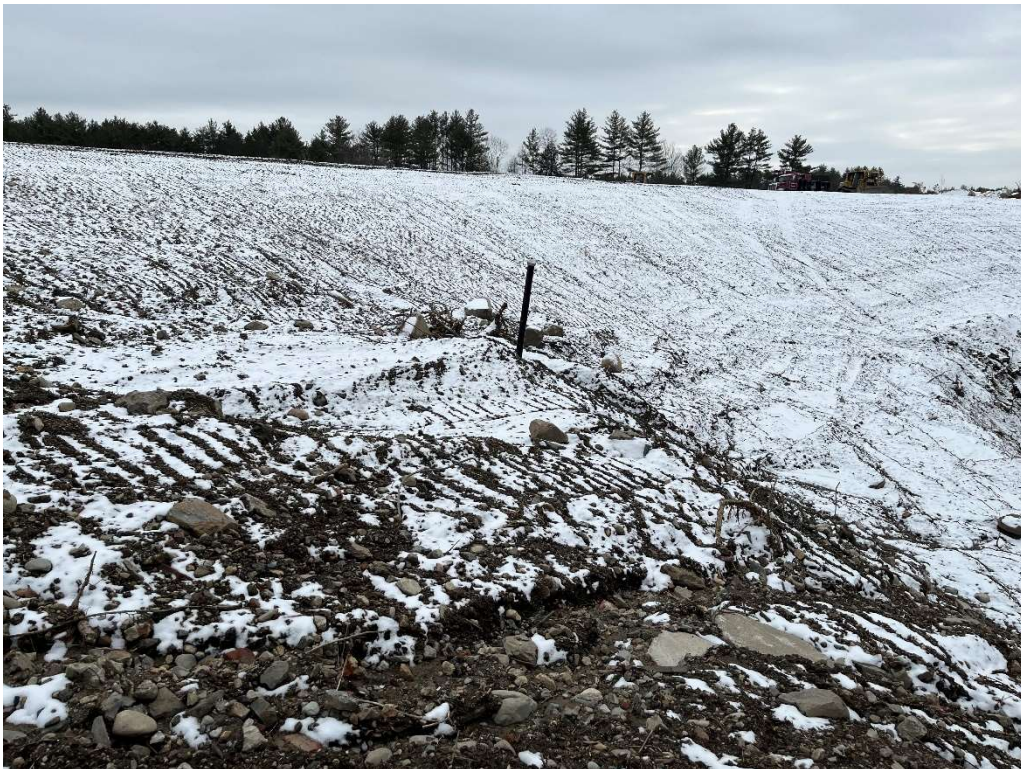
Photo 10 – Grading at monitoring well.

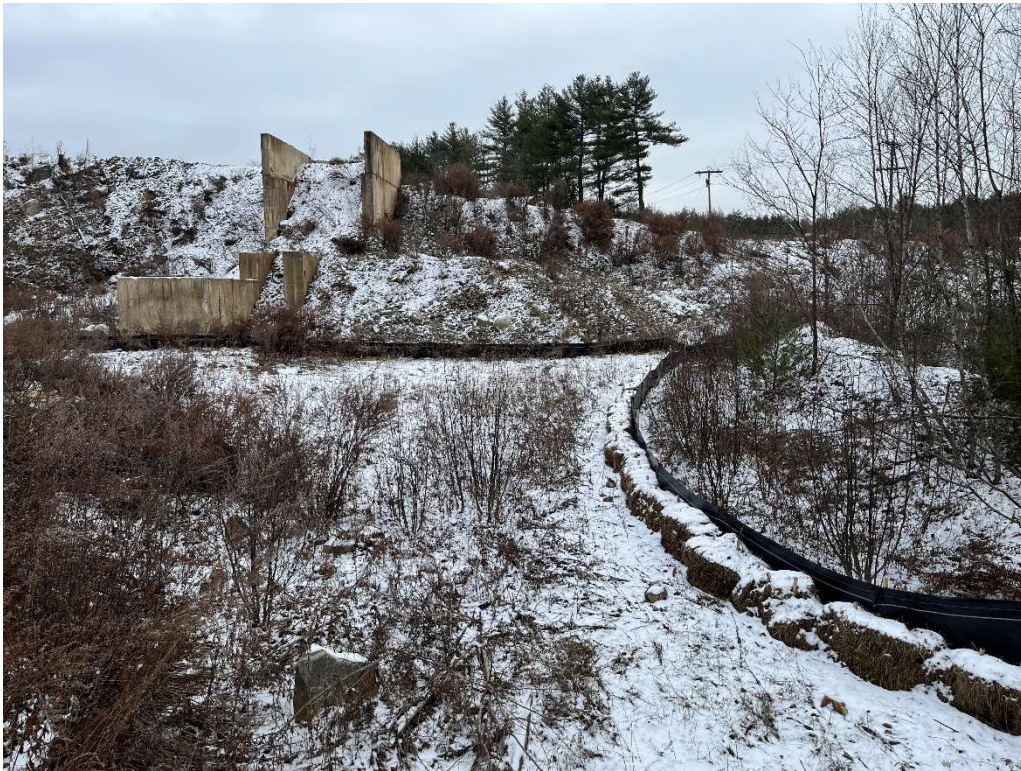
Photo 11 – Existing slope and erosion control at the southern limits of the Site.
