**109 Front Street
Winchendon, MA 01475**

MEMORANDUM

**FROM: Patrick Wood, Town Engineer
SUBJECT: May 2024 Mabardy Landfill Site Observation**

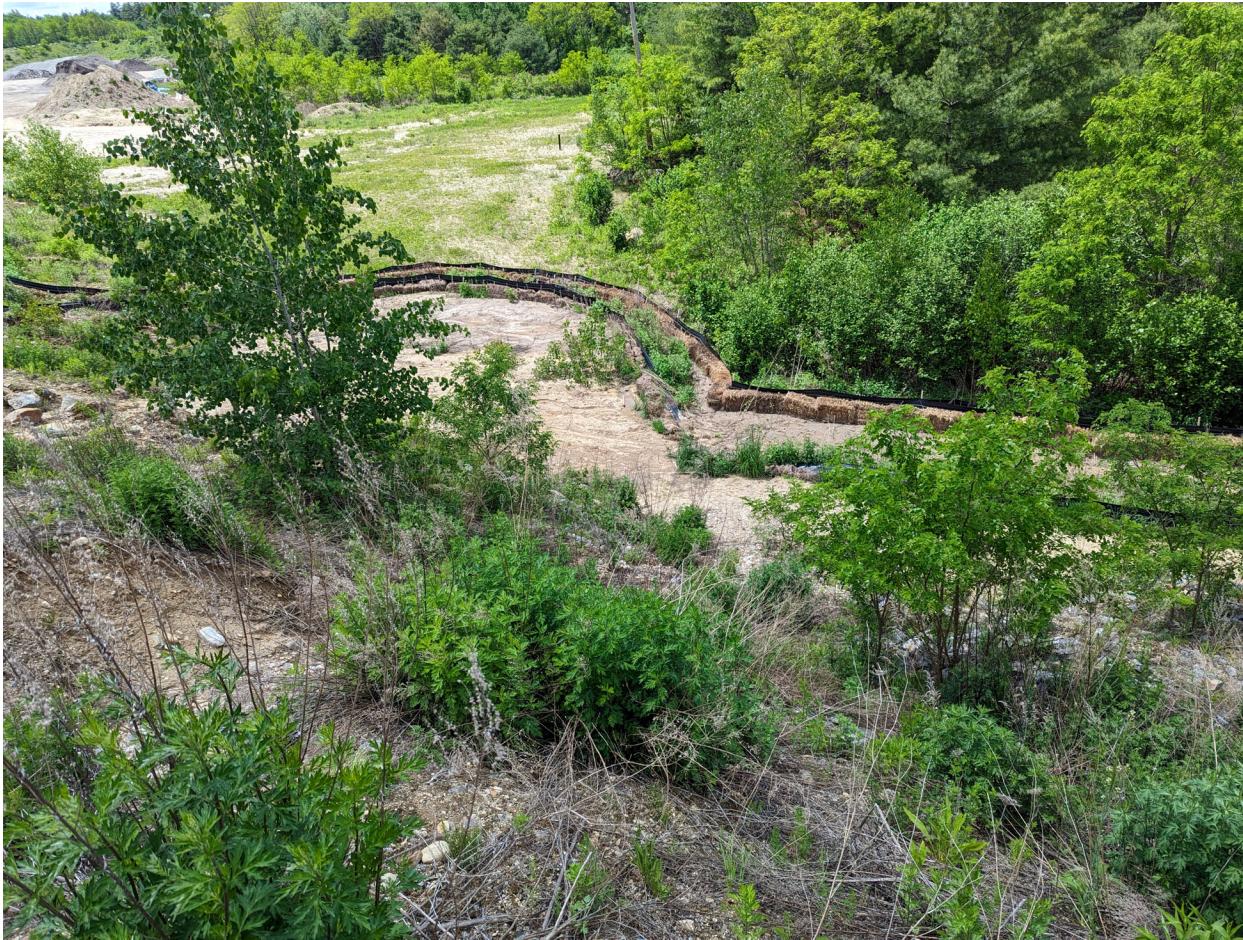
Figure 2

The new silt fencing and hay bales which were installed in March 2024 along the front of the previous erosion controls, continue to be in good shape with minimal sediment accumulated. See photos below.

Continue to monitor the fines that migrate down to the new erosion controls and excavate them as needed. Sediment shall be removed when they reach half the depth of the hay bales. Please note, that inspections of some of the erosion controls are difficult due to high vegetation.
