**109 Front Street  
Winchendon, MA 01475**

**MEMORANDUM**

**FROM: Patrick Wood, Town Engineer  
SUBJECT: July 2024 Mabardy Landfill Site Observation**

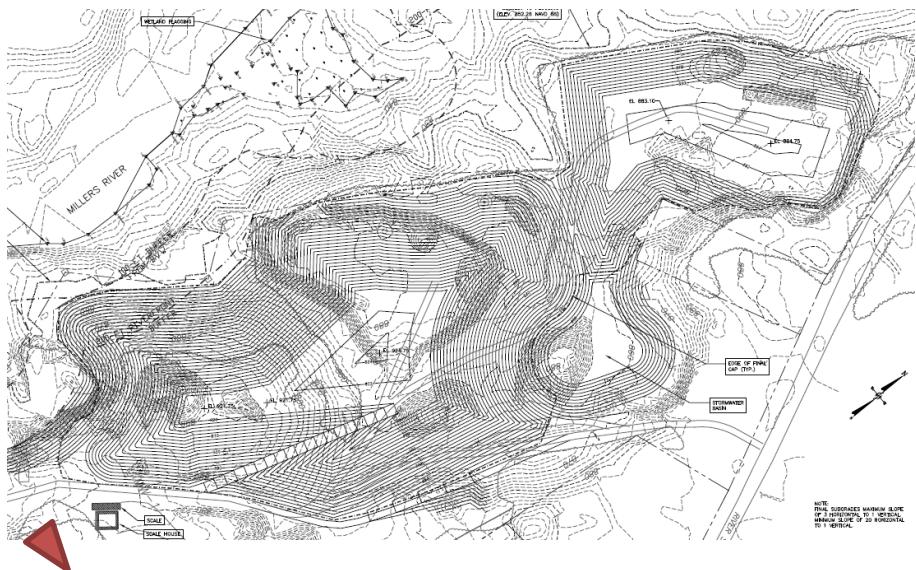
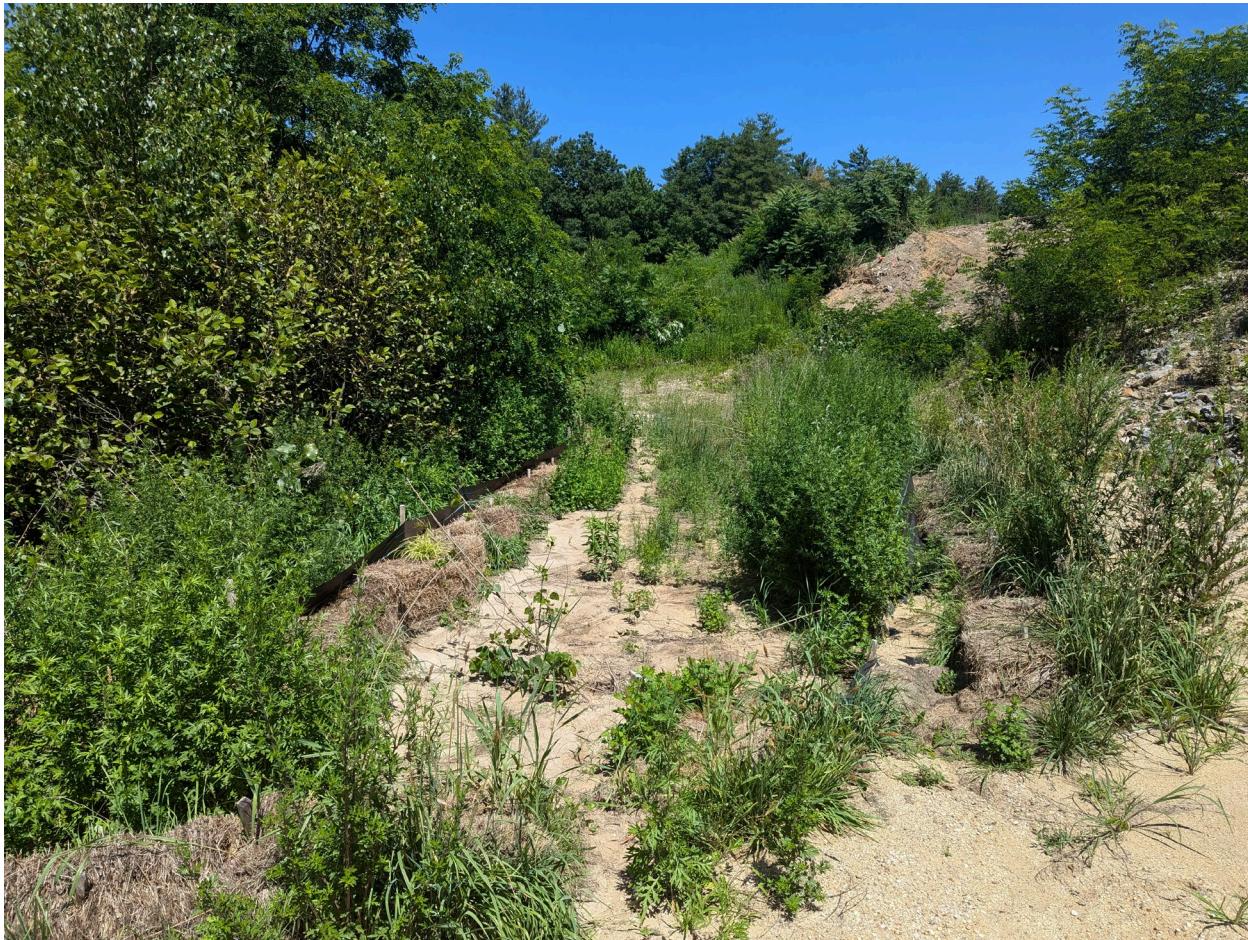
Figure 2

Vegetation has been growing along the hydorseeded slopes of the perimeter. Previous areas of erosion have been partially stabilized with vegetation and appear to be maintained. There are some exceptions, such as the gully that is present at the south-west portion of the site, see photo 1. These are areas of

erosion due to the sandy swales that have formed during rainfall events. Maintenance and monitoring will need to be continued in these areas to ensure there is minimal undermining and soil migration.

Monitor gullies that form in the slope. Continue to fill them in materials to remove the gullies, as possible as additional rain will continue to deepen the gullies.

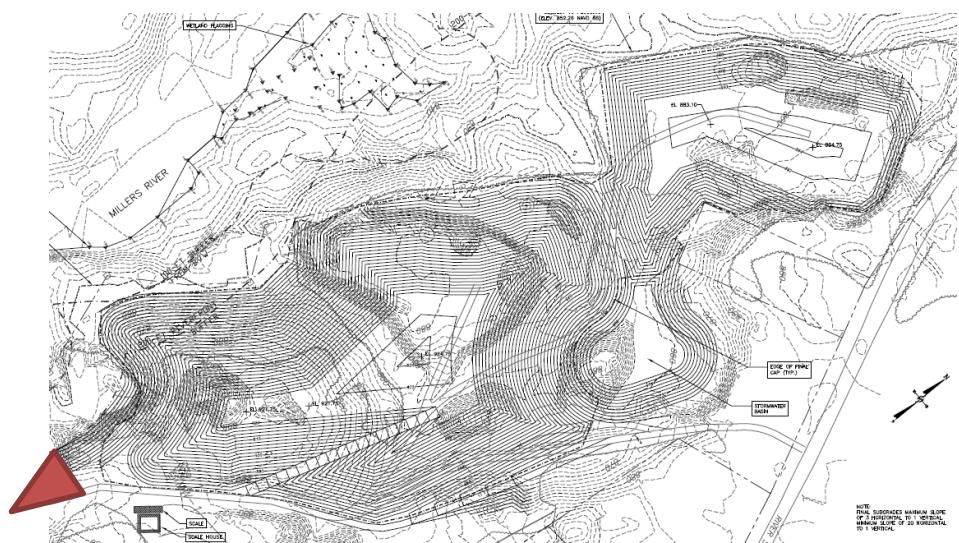
Figure 3

The new silt fencing and hay bales which were installed in March 2024 along the front of the previous erosion controls, continue to be in good shape with minimal sediment accumulated. See photos below.

Continue to monitor the fines that migrate down to the new erosion controls and excavate them as needed. Sediment shall be removed when they reach half the depth of the hay bales. Please note, that inspections of some of the erosion controls are difficult due to high vegetation.
