# EXPANDED ENVIRONMENTAL NOTIFICATION FORM

Whites Pond Dam Removal and Stream Restoration Project Winchendon, Massachusetts

Owner and Applicant: The Mill Farm Initiative 155 Mill Circle Winchendon, Massachusetts 01475

Prepared by: GZA GeoEnvironmental, Inc. 249 Vanderbilt Avenue Norwood, Massachusetts 02062

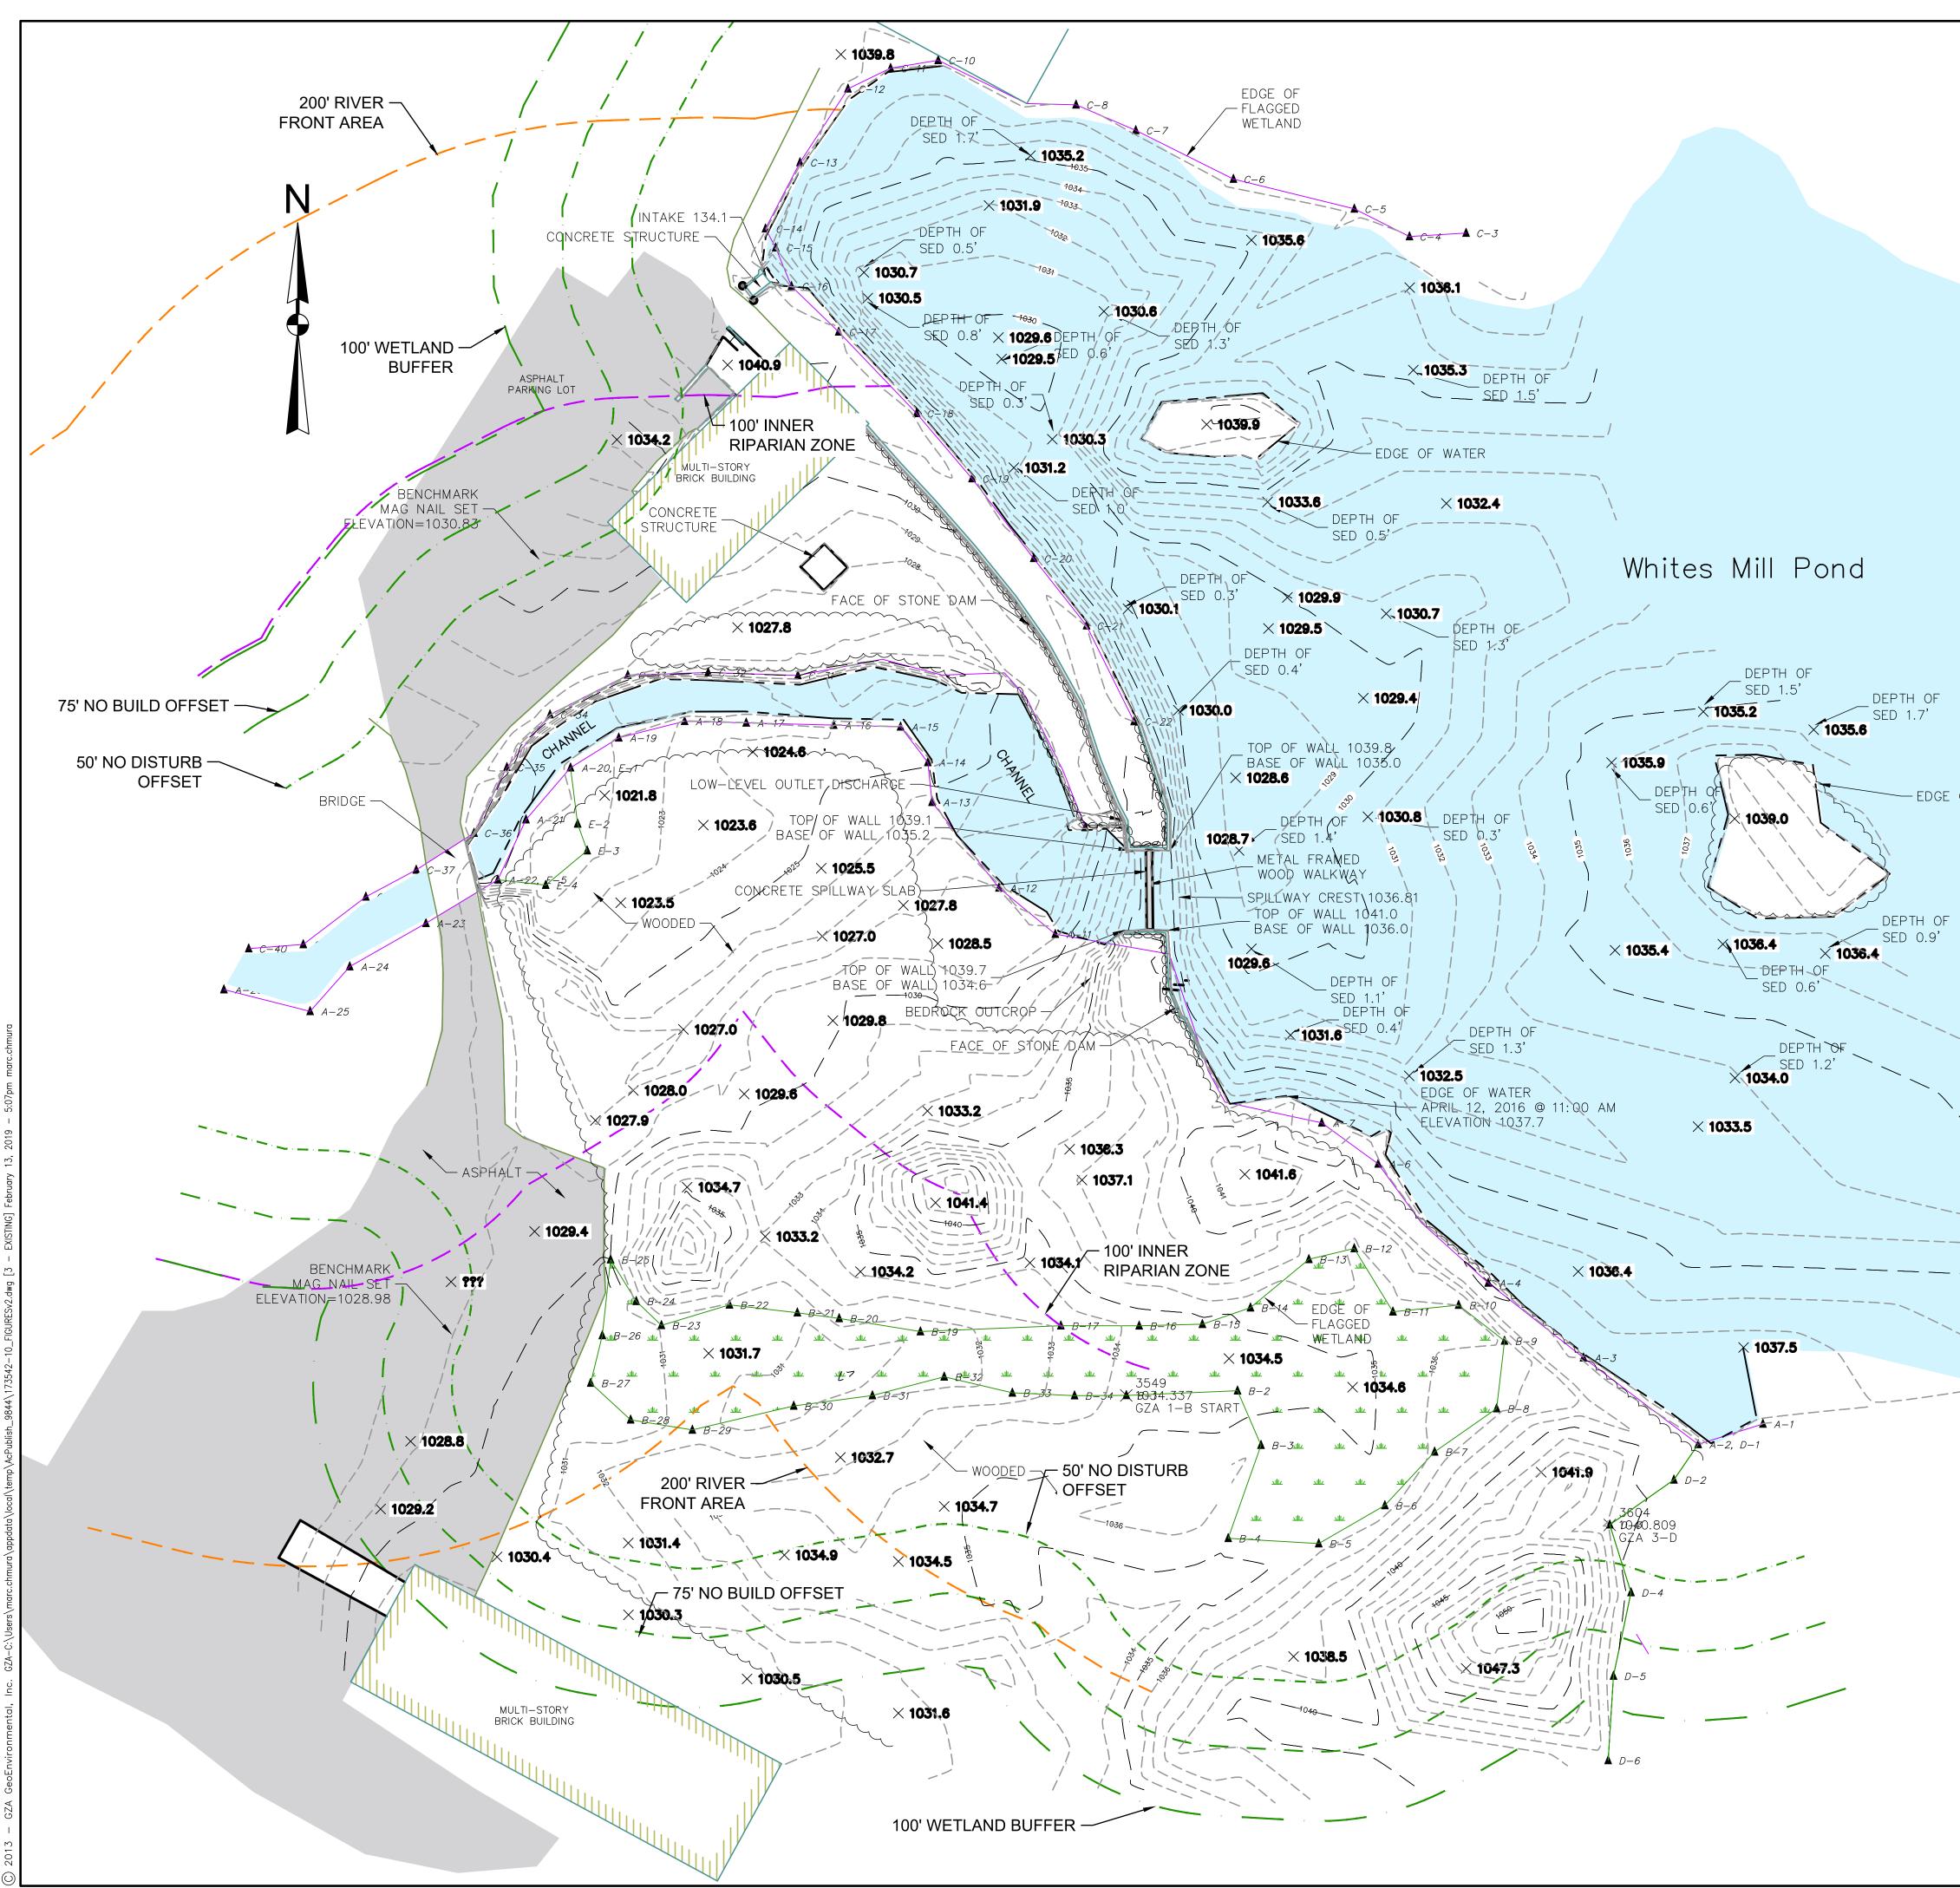
LEC	GEND				
			EXISTING 1' MINOR	CONTOUR		
			EXISTING 5' MAJOR			
	× de Se			NT AS MEASURED W	ITH PROBE (FEET)	
	B		RESOURCE AREA DI LIMIT OF BVW	ELINEATION -		
	A	<u>, − 1</u> F	RESOURCE AREA DI FOP OF BANK OF PE	ELINEATION - ERENNIAL STREAMS	AND RIVERS	
	~	~~~~	TREE/ VEGETATION	I LINE		
			EXISTING BUILDING	3		
	عللد	يالد .	BORDERING VEGET	TATED WETLANDS (E	3VW)	
			WHITES POND / NC (NORMAL POOL)	ORTH BRANCH OF M	ILLER'S RIVER	
	_		100' INNER RIPAR	IAN ZONE		
	_		200' RIVER FRON	T AREA		
			50' NO DISTURB C	DFFSET		
	<b></b> , ,		75' NO BUILD OFF	SET

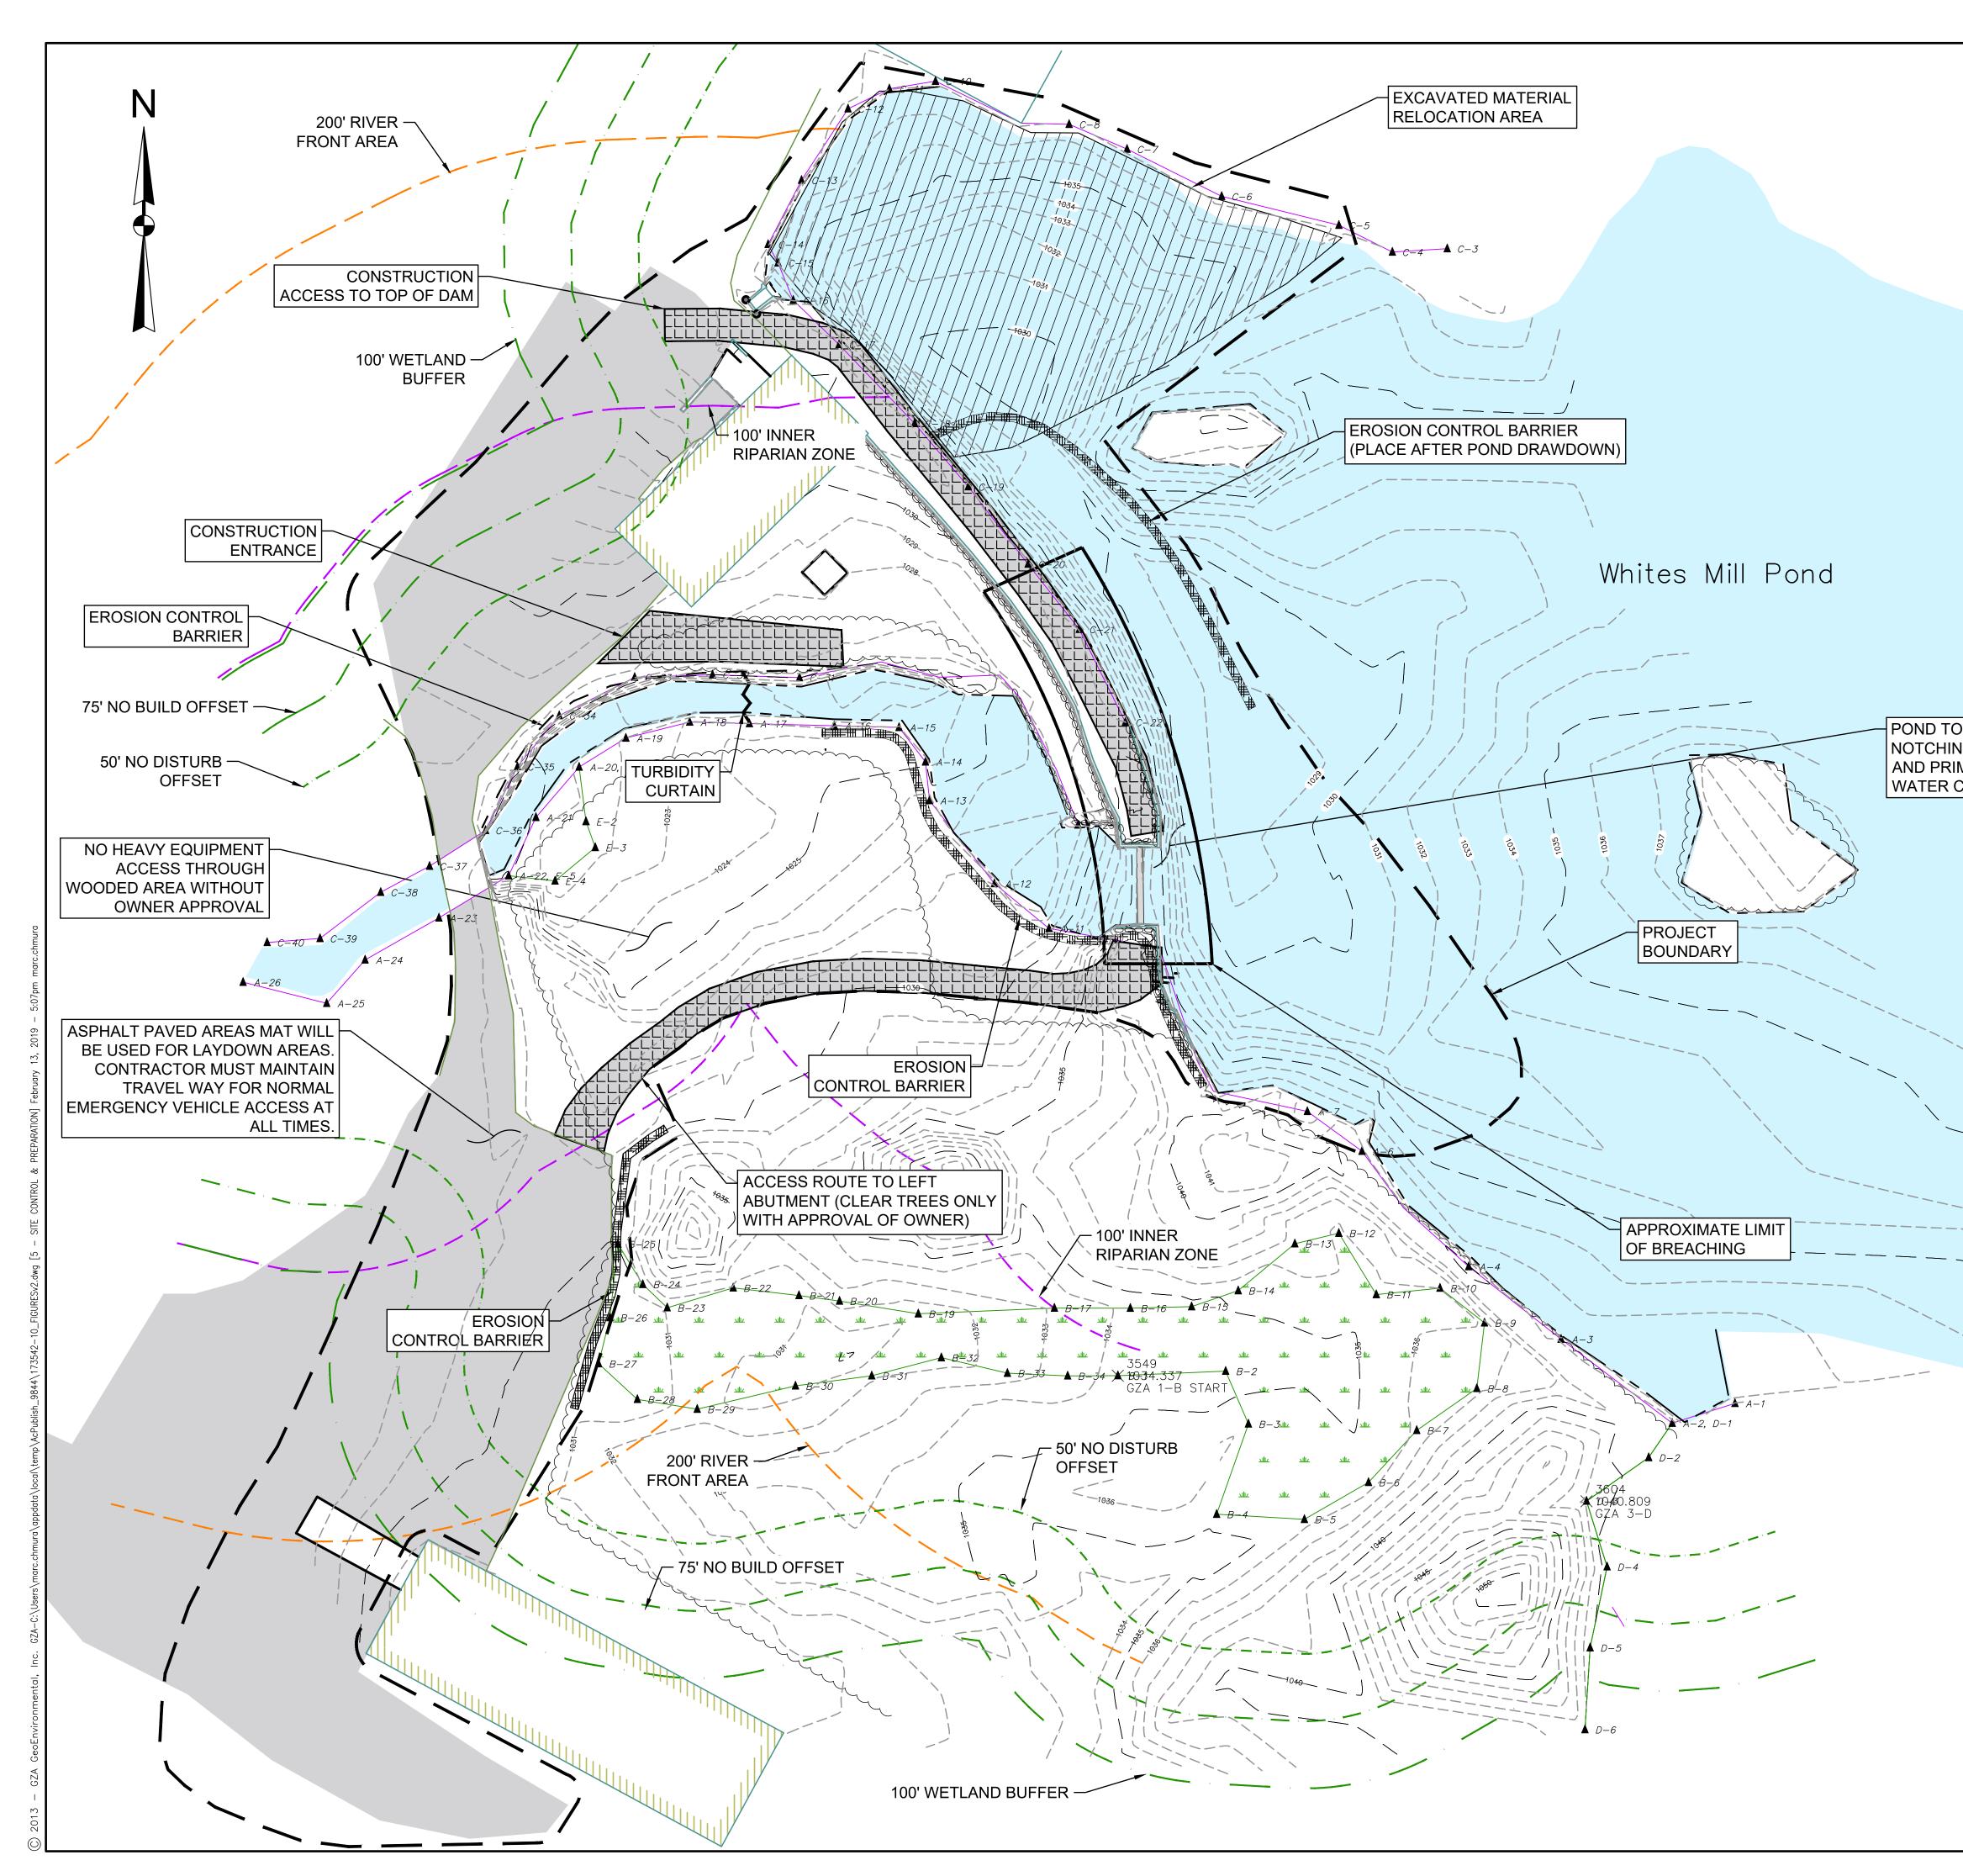
LEGEND
	— — EXISTING 1' MINOR CONTOUR
	EXISTING 5' MAJOR CONTOUR
	B-1 RESOURCE AREA DELINEATION - LIMIT OF BVW
	A-1 TOP OF BANK OF PERENNIAL STREAMS AND RIVERS
	TREE/ VEGETATION LINE
	EXISTING BUILDING
	BORDERING VEGETATED WETLANDS (BVW)
	WHITES POND / NORTH BRANCH OF MILLER'S RIVER (NORMAL POOL)
	PROJECT BOUNDARY
	— — 100' INNER RIPARIAN ZONE
	— — 200' RIVER FRONT AREA
TO BE LOWERED BY GRADUALLY ING BREACH IN EMBANKMENT RIMARY SPILLWAY. REFER TO	= = = = 50' NO DISTURB OFFSET
R CONTROL NOTES.	- 75' NO BUILD OFFSET
	100' WETLAND BUFFER
	0 15 30 60 90
	SCALE IN FEET
	PERMIT DRAWING SET

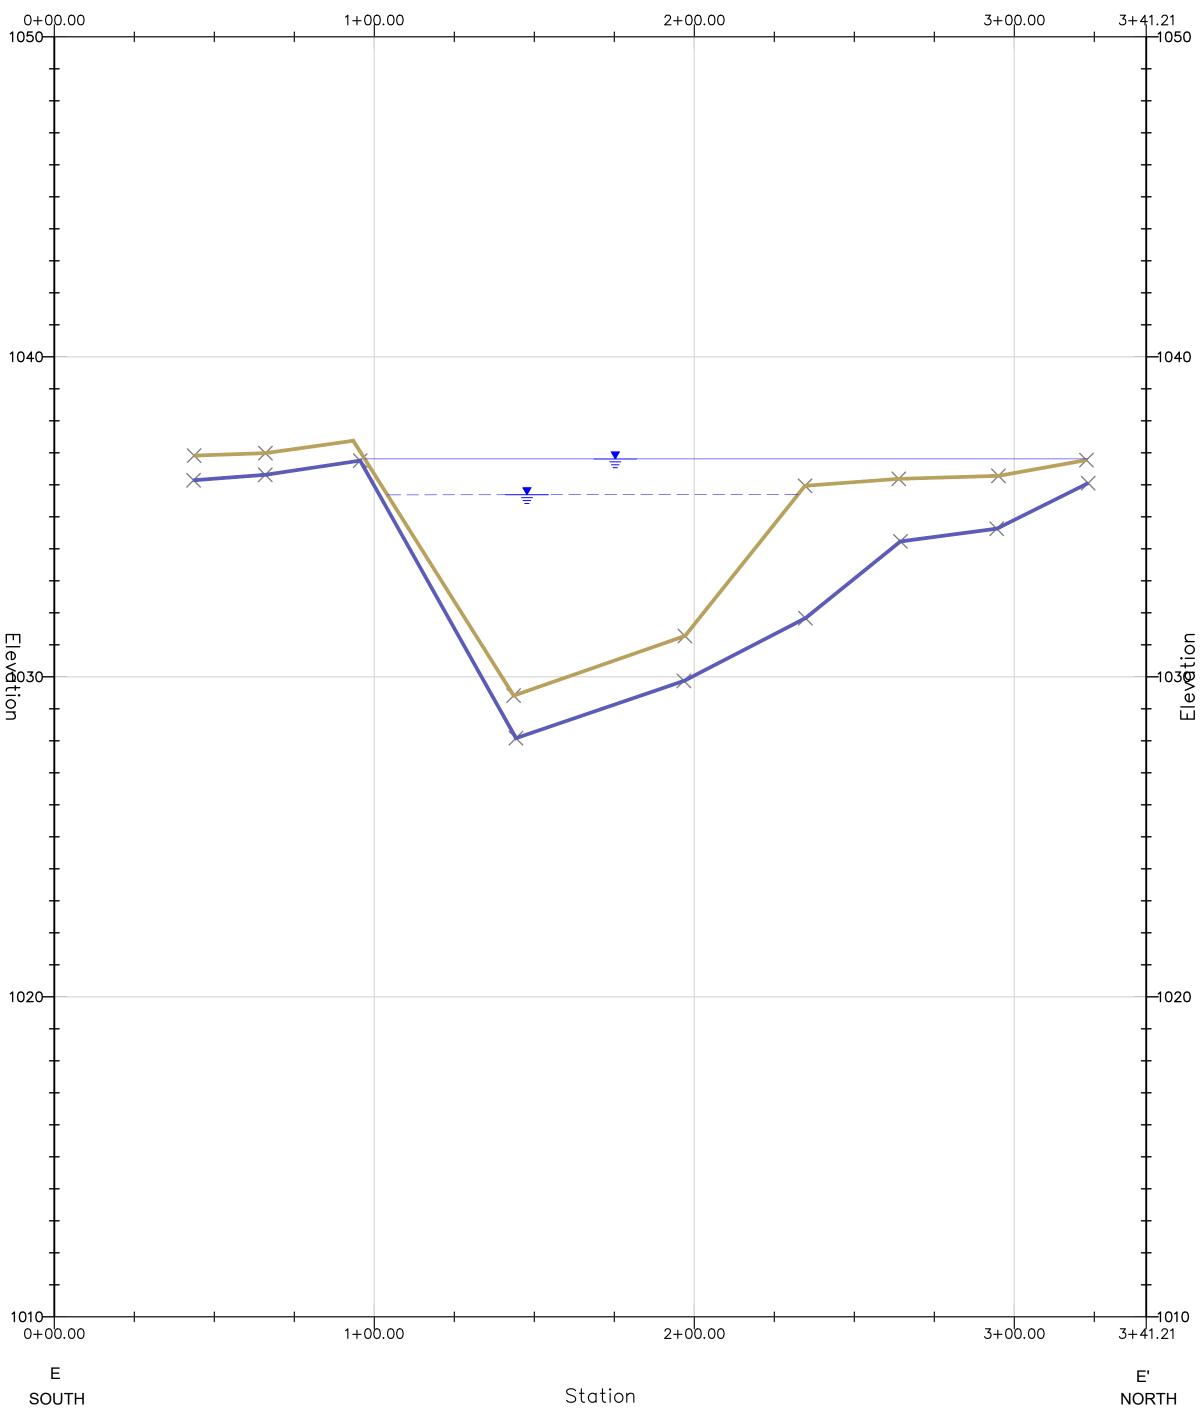
### PROFILE VIEW OF ALIGNMENT - E

APPROXIMATE NORMAL POOL – – – – APPROXIMATE WATER ELEVATION POST BREACH ANTICIPATED SEDIMENT TRANSPORTED DOWNSTREAM

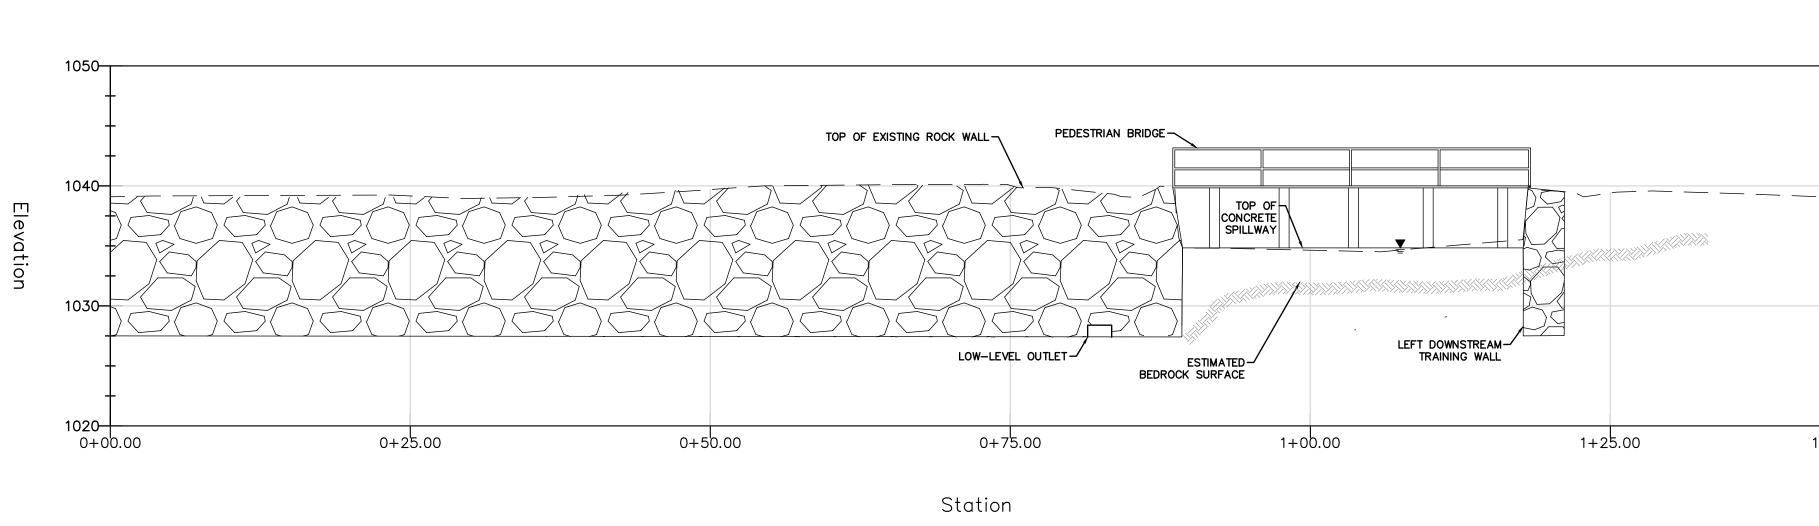
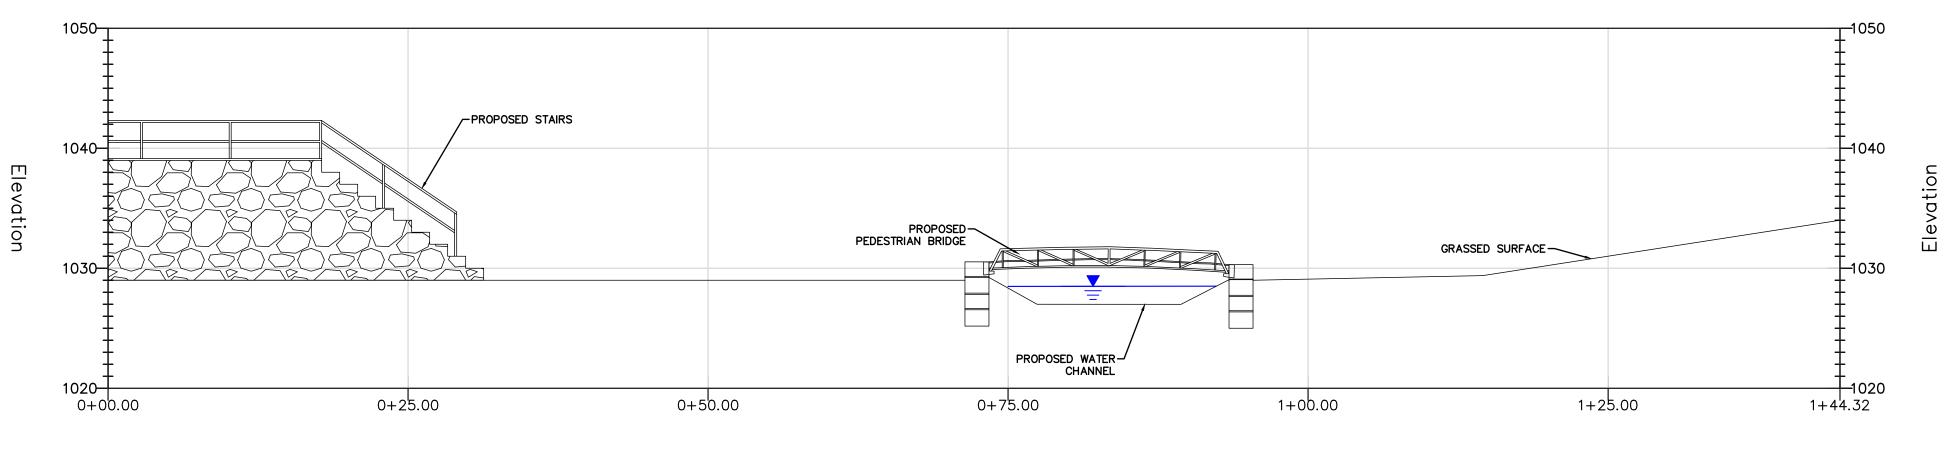
### PROFILE VIEW OF DAM - EXISTING UPSTREAM PERSPECTIVE

PROFILE VIEW OF DAM - PROPOSED UPSTREAM PERSPECTIVE

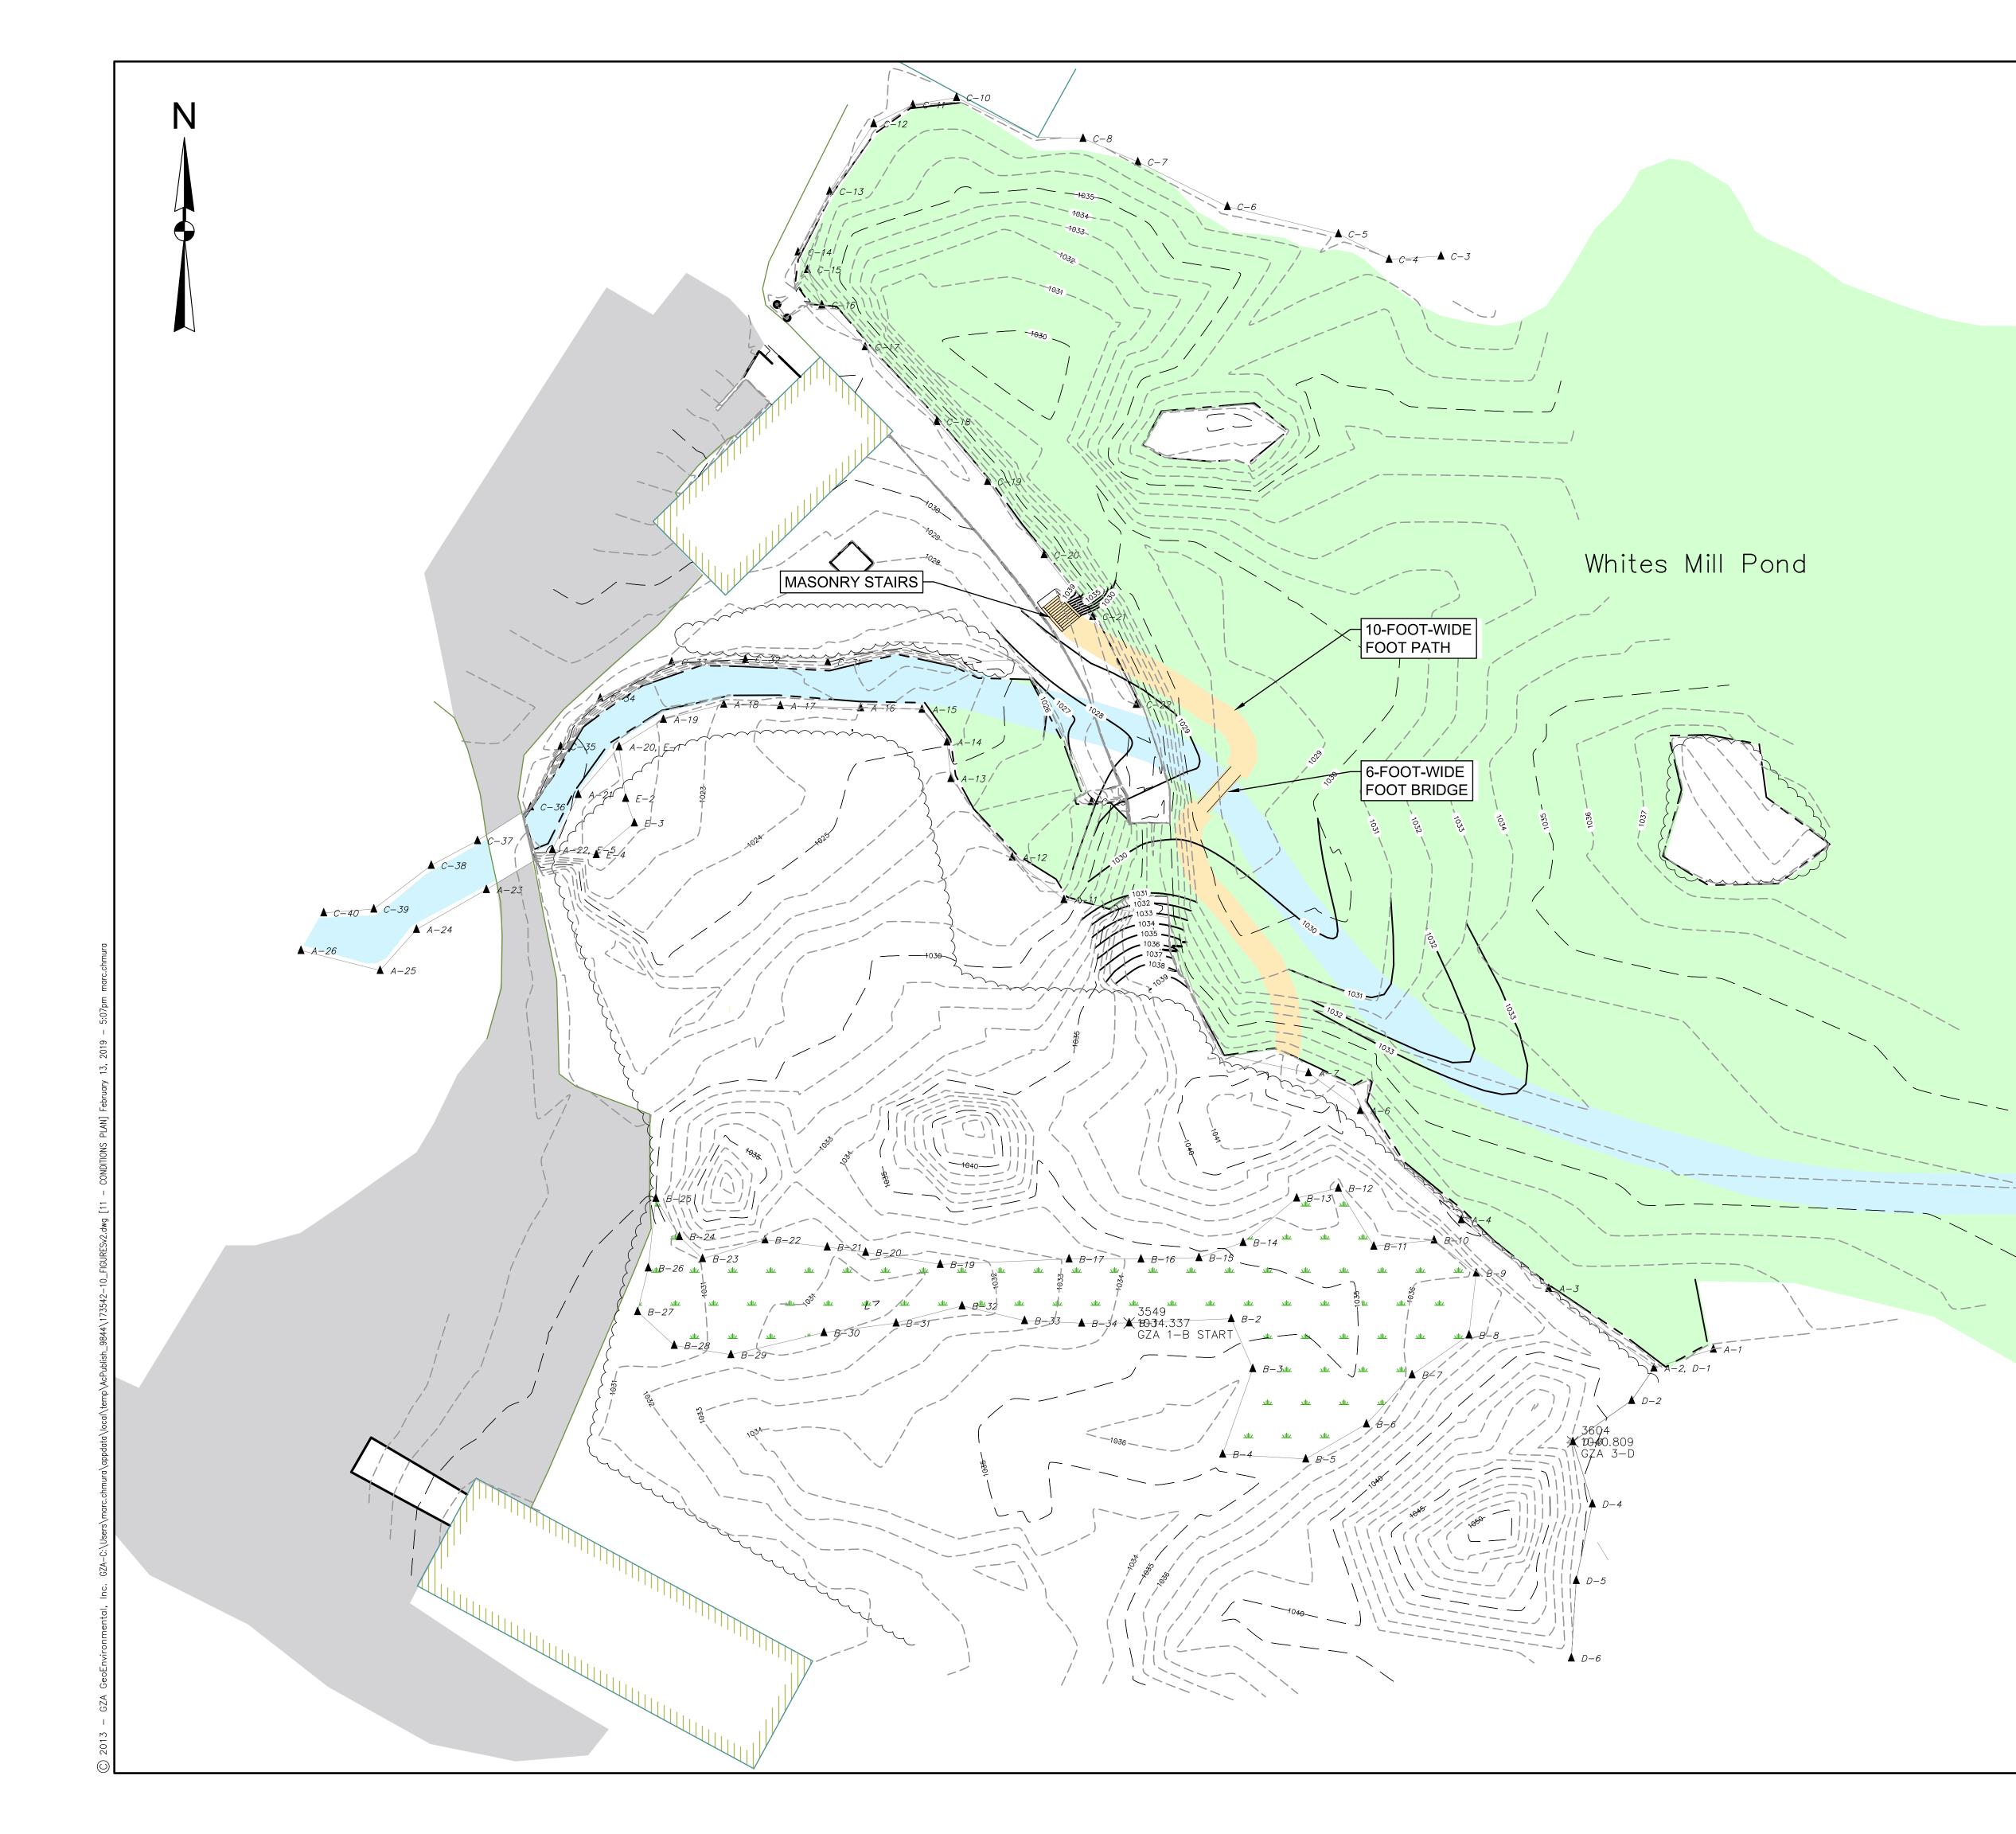
<u></u>			
			EXISTING 1' MINOR	CONTOUR		
			EXISTING 5' MAJOR	CONTOUR		
			PROPOSED CONTO	UR		
	B-1 RESOURCE AREA DELINEATION - LIMIT OF BVW					
	A	<u>\</u> _1	RESOURCE AREA I TOP OF BANK OF F	DELINEATION - PERENNIAL STREAMS	S AND RIVERS	
	$\sim$	~~~~	TREE/ VEGETATIC	N LINE		
			EXISTING BUILDIN	G		
	عللد	عللد	BORDERING VEGE	ETATED WETLANDS (	BVW)	
			PROPOSED MILLE	R'S RIVER		
			FORMER POND AF	REA		
			PROPOSED PEDES	STRIAN PATH		
				60 90 IN FEET		
GEOEN CLIENT THE D USE A TRANS EXPRE	NO. ISSUE/DESCRIPTION BY DATE JNLESS SPECIFICALLY STATED BY WRITTEN AGREEMENT, THIS DRAWING IS THE SOLE PROPERTY OF GZA GEOENVIRONMENTAL, INC. (GZA). THE INFORMATION SHOWN ON THE DRAWING IS SOLELY FOR USE BY GZA'S CLIENT OR THE CLIENT'S DESIGNATED REPRESENTATIVE FOR THE SPECIFIC PROJECT AND LOCATION IDENTIFIED ON THE DRAWING. THE DRAWING SHALL NOT BE TRANSFERRED, REUSED, COPIED, OR ALTERED IN ANY MANNER FOR JSE AT ANY OTHER LOCATION OR FOR ANY OTHER PURPOSE WITHOUT THE PRIOR WRITTEN CONSENT OF GZA. ANY TRANSFER, REUSE, OR MODIFICATION TO THE DRAWING BY THE CLIENT OR OTHERS, WITHOUT THE PRIOR WRITTEN EXPRESS CONSENT OF GZA, WILL BE AT THE USER'S SOLE RISK AND WITHOUT ANY RISK OR LIABILITY TO GZA. WHITES MILL POND DAM DAM DECOMMISSIONING AND STREAM RESTORATION PROJECT WINCHENDON, MASSACHUSETTS

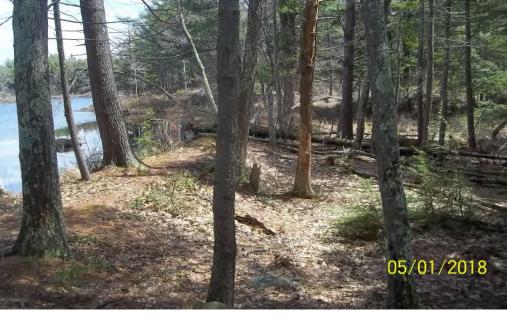
Uprooted trees along upstream side of dike.

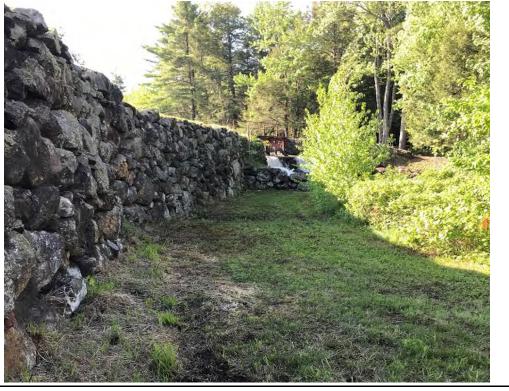
Downstream face of dam from right abutment.

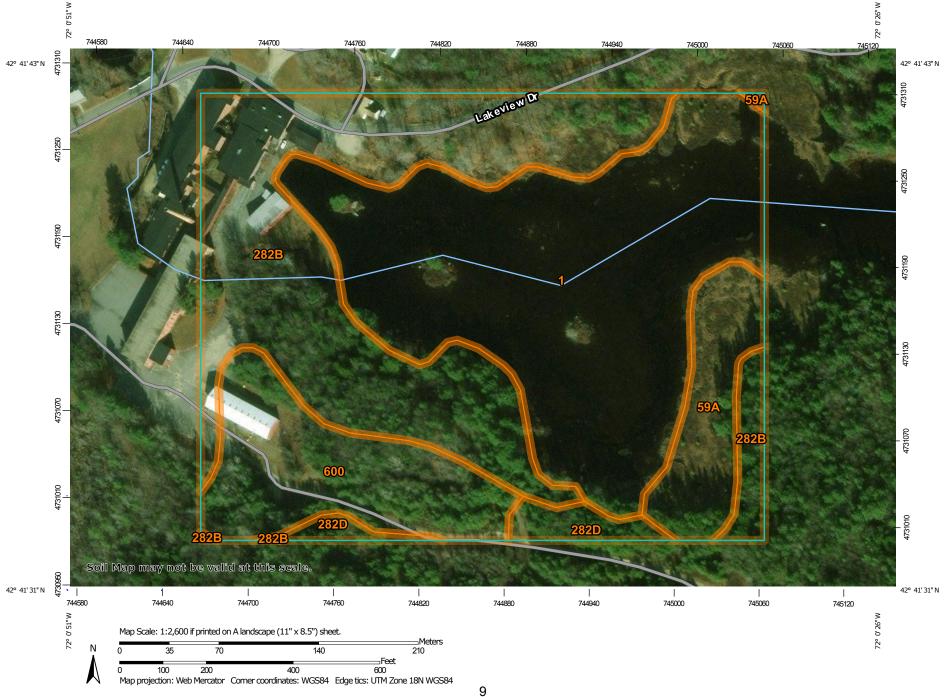
# Custom Soil Resource Report Soil Map (Whites Mill Pond Dam)

The soil map section includes the soil map for the defined area of interest, a list of soil map units on the map and extent of each map unit, and cartographic symbols displayed on the map. Also presented are various metadata about data used to produce the map, and a description of each soil map unit.

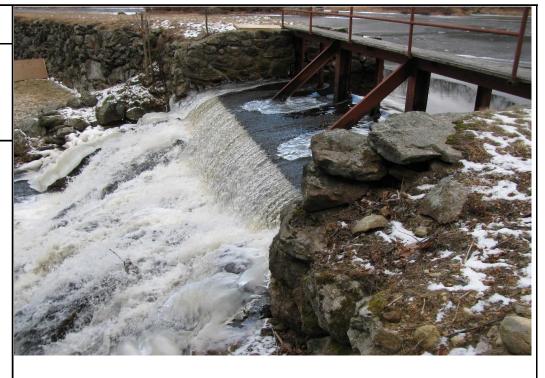
Top of dam and spillway. Note timber cover of low area at right end of catwalk and over seepage area at base of stone wall.

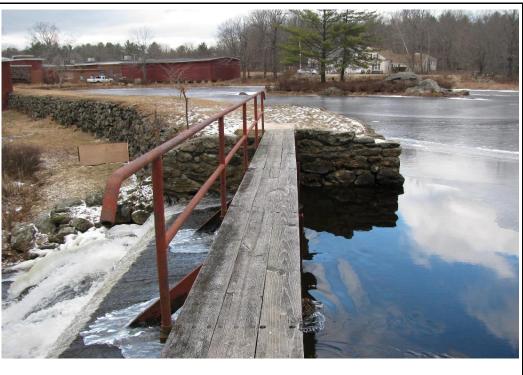
dam on right bank of discharge channel. Low stone wall separating area from immediate toe of dam area. Note plywood shelter built over seepage area at toe of wall.

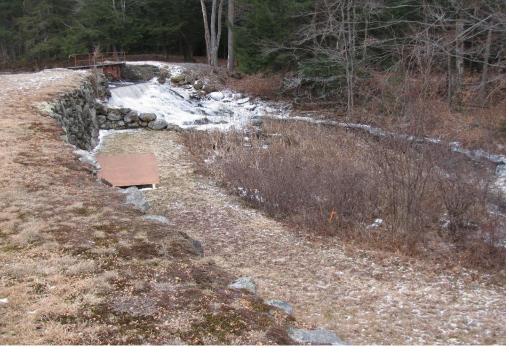
**Description:** Top of left embankment section and left abutment.

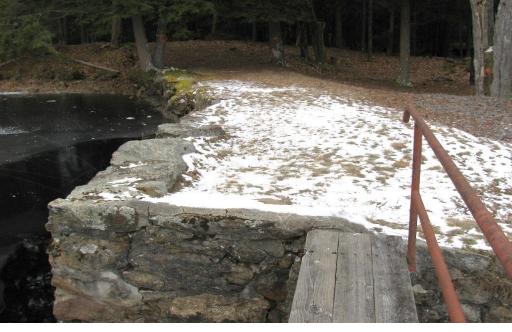
Downstream masonry mall and low "training wall" separating low level outlet area from toe of dam. Note two trees which have been lopped.

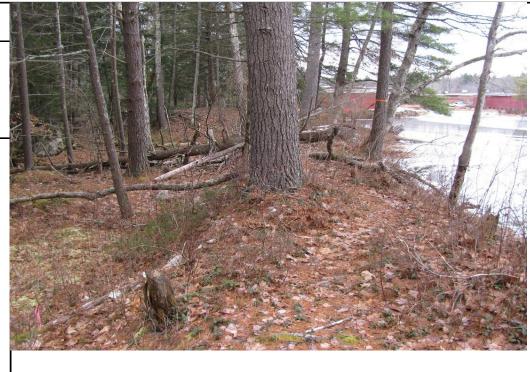
Direction Photo Taken: facing west

**Description:** Top of Dike to left of spillway. Note large trees
