Three Oaks Environmental

December 14, 2023

Chris Mossman Re: Wetlands Delineation

ccmossman@troweng.net 302 Maple St. Winchendon

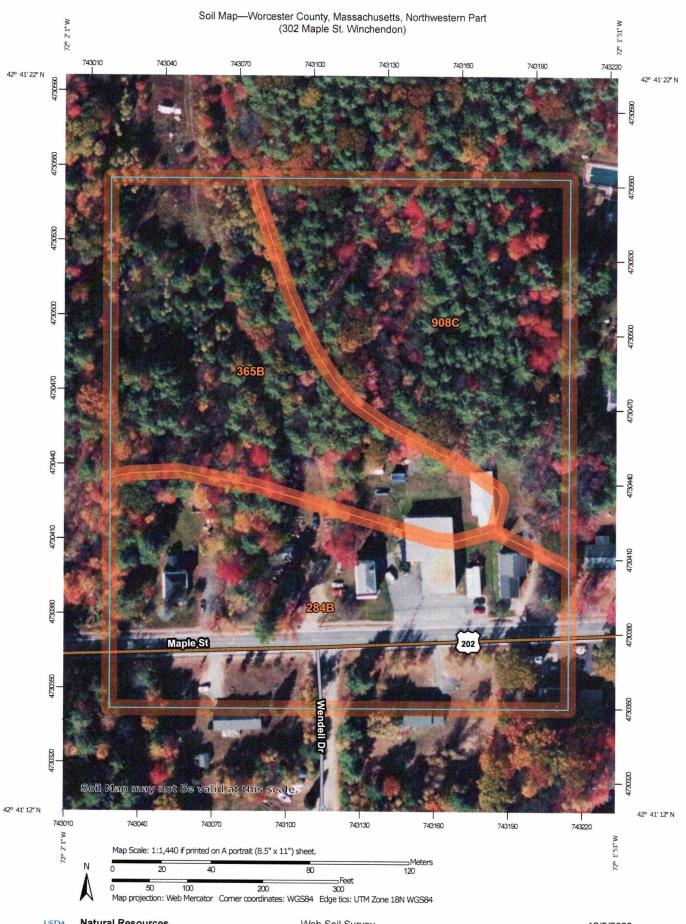
Map Unit Legend

Map Unit Symbol	Map Unit Name	Acres in AOI	Percent of AOI
284B	Croghan loamy fine sand, 3 to 8 percent slopes	3.7	37.4%
365B	Skerry fine sandy loam, 3 to 8 percent slopes	3.0	30.2%
908C	Becket-Skerry association, 0 to 15 percent slopes, extremely stony	3.2	32.4%
Totals for Area of Interest		9.8	100.0%
