Winchendon Senior Center  
Conditions Assessment  
January 2020

### **Winchendon Senior Center**

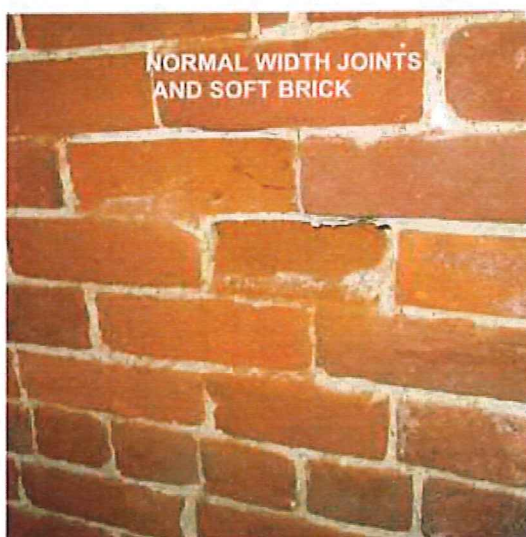
**Photo 5 - Tower Interior Brick and Mortar**

Construction of Outer Wythe of Brick The exterior brick of the WSC is hard medium-red with fine mortar joints while the back-up inner wythe brick is a common salmon brick with conventional mortar joints (See Photos 5 and 6). The outer brick is laid up in running bond with no apparent headers. They may have used blind headers, which is a technique where they take the back-up brick and rotate them occasionally into notches cut into the back of the facing brick. Without dismantling the masonry, this condition cannot be determined for certain. The facing brick expands and contracts differently than the backup brick due to different heat and moisture exposure as well as due to different absorption properties. The result is that over time the outer brick separates from the inner brick and a void occurs in the collar joint between wythes. As water enters the collar joint and freezes, it gradually works the exterior brick outward. The evidence of this effect can be seen at the brownstone detailing at the edges of the stone where the brick was originally in alignment and has become proud of the stone (See Photo 9). Although the construction is anticipated to be the same throughout, the problem of movement of the outer wythe is manifesting only in certain portions of the elevations. Those locations are likely related to exposure and are places on the building with more moisture and temperature cycling occurring, such as on the south and east elevations.

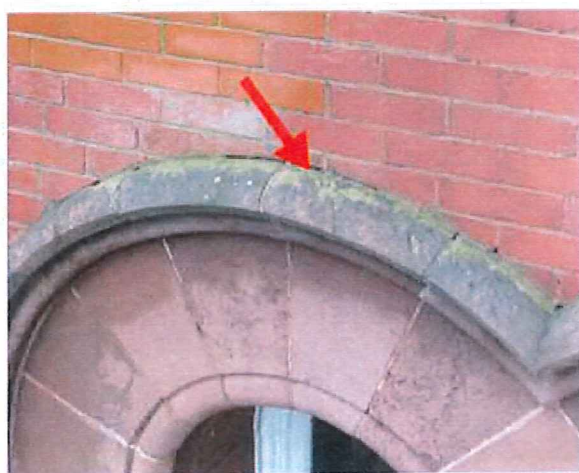
**Photo 7 - Projecting Elements Candidates for Flashing**

Flashing between dissimilar masonry and where stone profile creates a projecting surface were not observed in general. In only a few instances was a sealant applied in a repair application. There are dissimilar masonry conditions and projections that would benefit from flashing and sealants (See Photo 7).

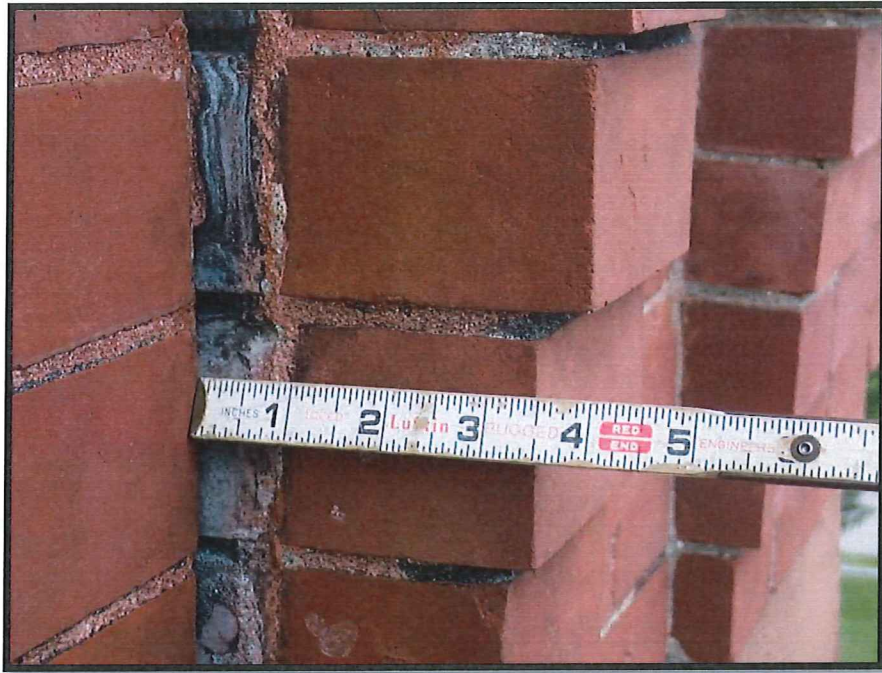
Appendix B – Photo 3

- The single wythe corbels on the east face of the tower are displaced outward carrying the brownstone arches and sill above the brownstone arches with them. The displacement is approximately 1-1/2 inches near the top of the corbel (See photo 3 Appendix B). The outward displacement continues above the brownstone into the brick and brownstone belt course above.
